Islamic Republic Of Iran
Civil Aviation Organization
Aircraft Accident Investigation Board

Final Report

Aircraft Model: Bombardier CL604 Challenger

Registration: TC-TRB

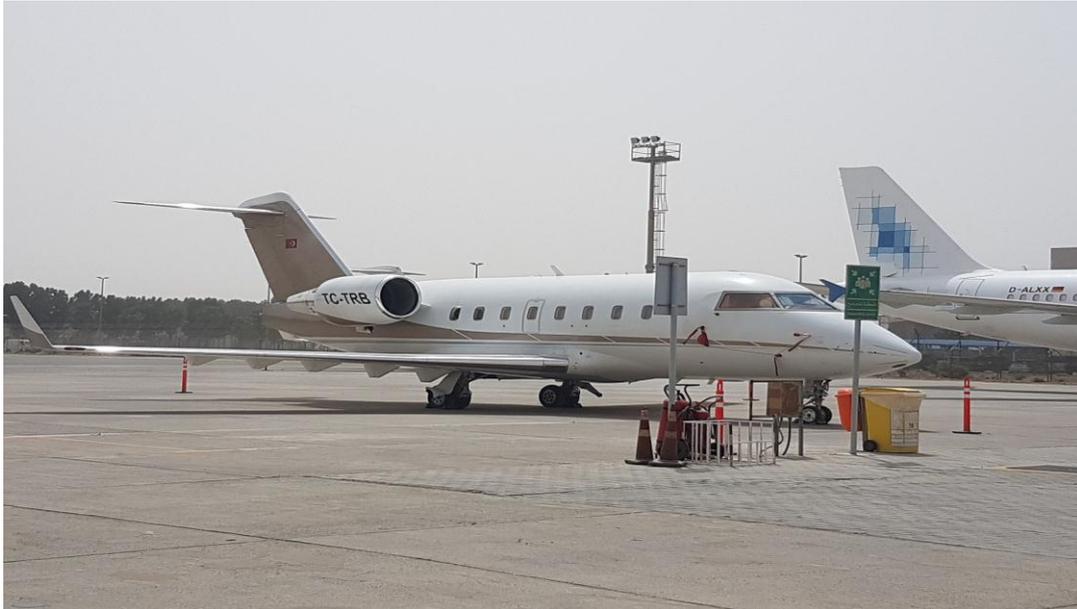
The aircraft had been parked for three days before flight in Sharjah International Airport. During the time, dusty weather condition was reported on the airport. A witness reported that initially crew did not set cover on Pitot tubes when aircraft was parked but picture of aircraft in parking showed that it was done later.

Park position of aircraft in Sharjah (OMSJ)

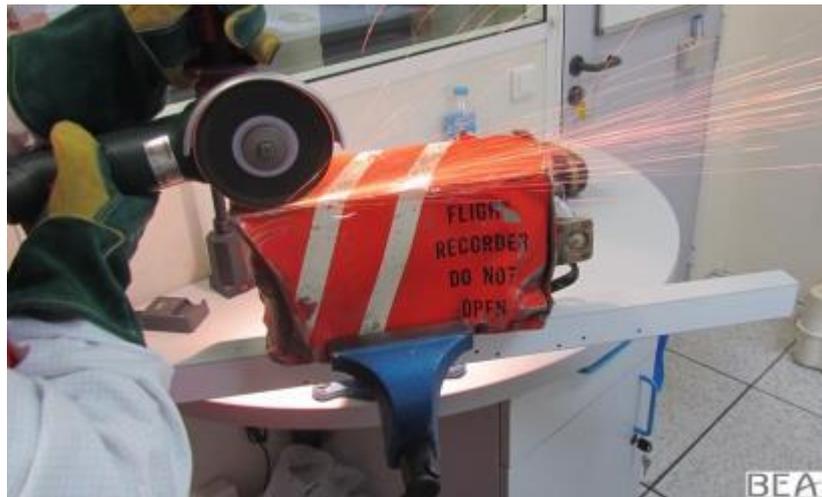
Due to the recorder's damage, the chassis was cut with electrical grinder to have a clear access to the main processor PWA.

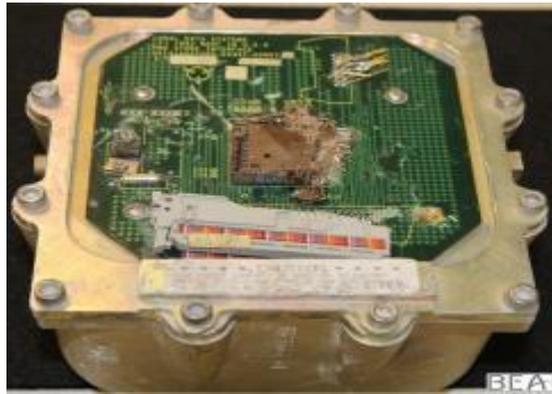
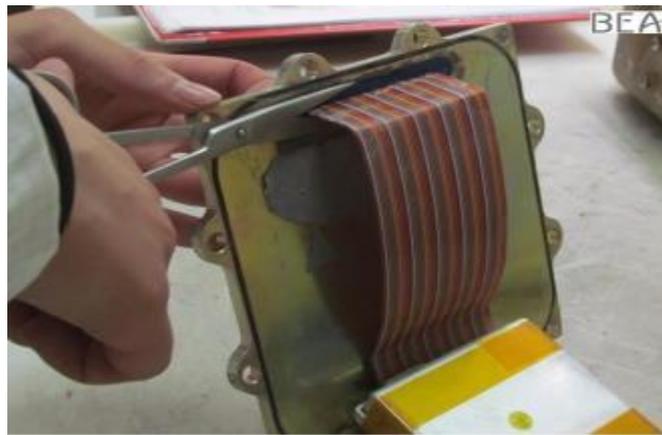
The FDR FCSSU was visually checked. The connector of the memory board was damaged.

The FCSSU was opened, the metallic casing of the memory board was extracted and the ribbon cable was cut close to the cover of the FCSSU.

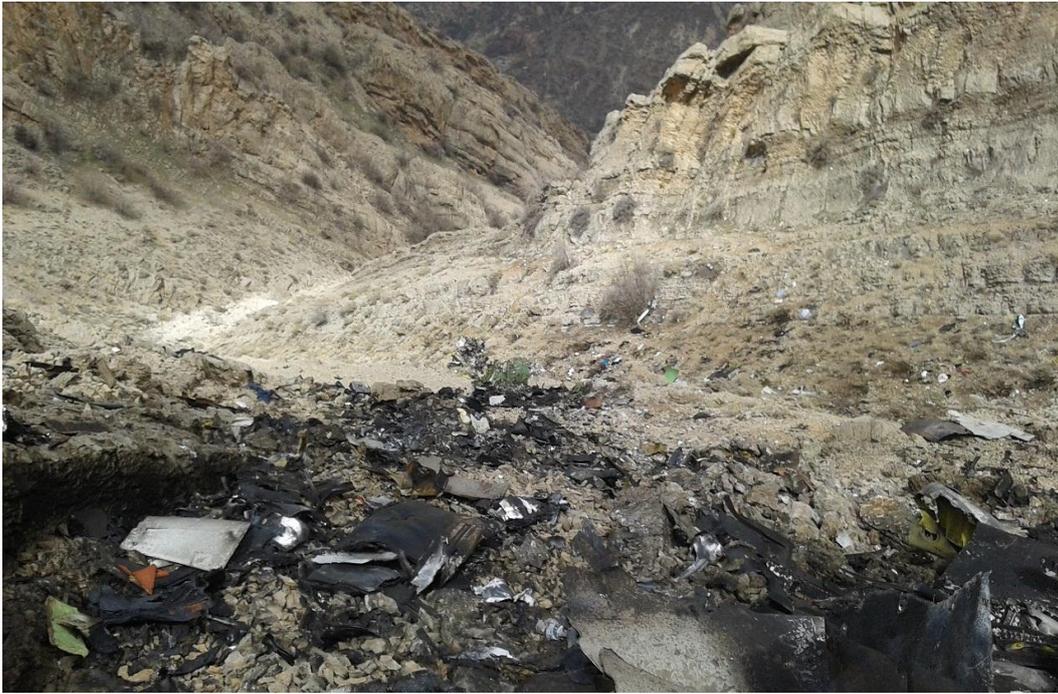
The investigation carried on Helen Mountain area along with the wreckage distribution pattern revealed that the initial contact with terrain has happened at an elevation of 7500 ft elevation, with the nose impacted first. As shown in the figures, the wreckage was scattered in an area of about 500 m long and 200 m wide on mountain slope. At the point of impact, there was a burned black hole about 3 m wide, 5 m long and 2 m deep. There was evidence of severe impact at this point with scattered parts from the cockpit, and nose section equipment of the aircraft. After the impact of the aircraft with the terrain, both engines were separated. Both engines were available at accident site and the condition of their rotating parts showed minimum engine rotation speed impact. The right and left wings as well as the forward fuselage including the cockpit, completely burned in the post-impact fire. It seemed that the aircraft had integrity before impact to mountain area.

Impact point and the wreckage of the aircraft

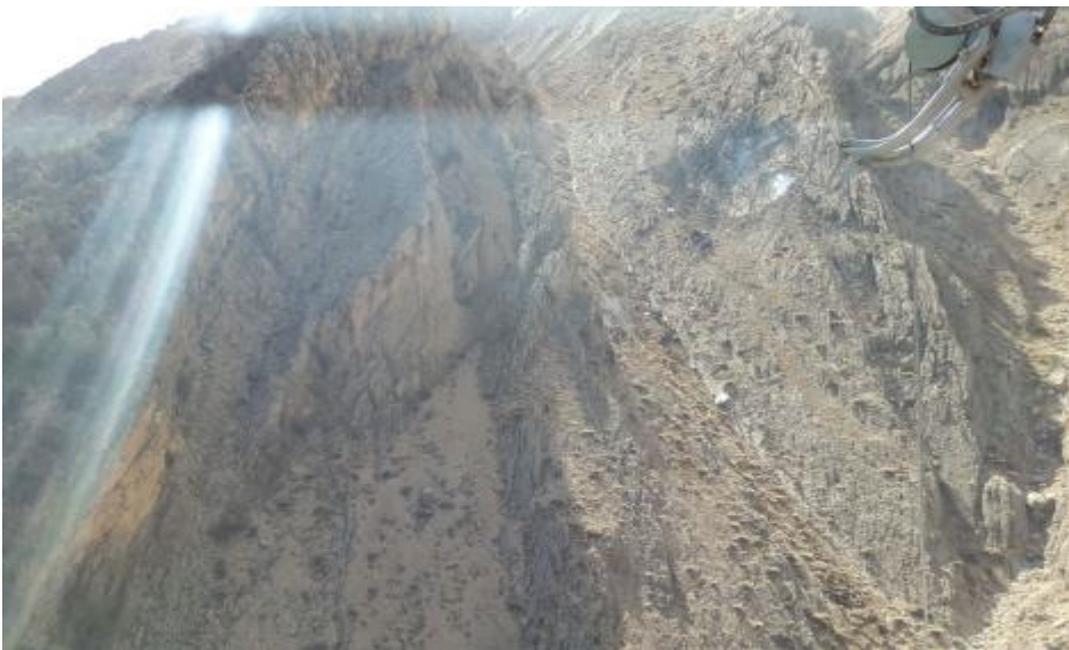
Impact point of the aircraft

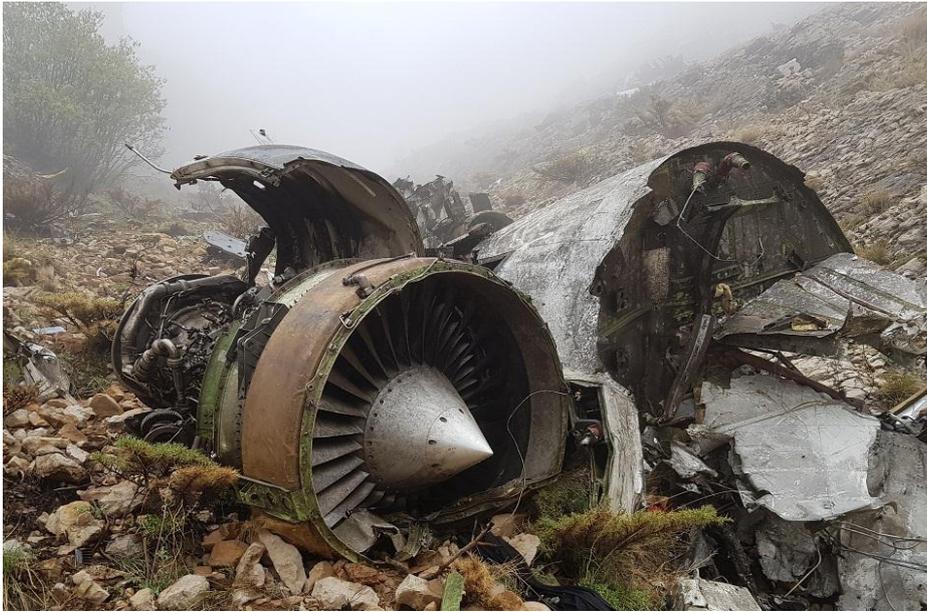
Engine #2

The data shows an eventual and progressive deterioration of engine performance parameters until shutdown of both engines. It is likely that the disturbed airflow caused by the rapid and repeated pitch oscillations eventually caused internal damage to the engines, resulting finally

in the inability of the engines to continue to operate. It is likely that the engines were sufficiently damaged as a result, such that it would have been impossible to re-start them following the shutdown.

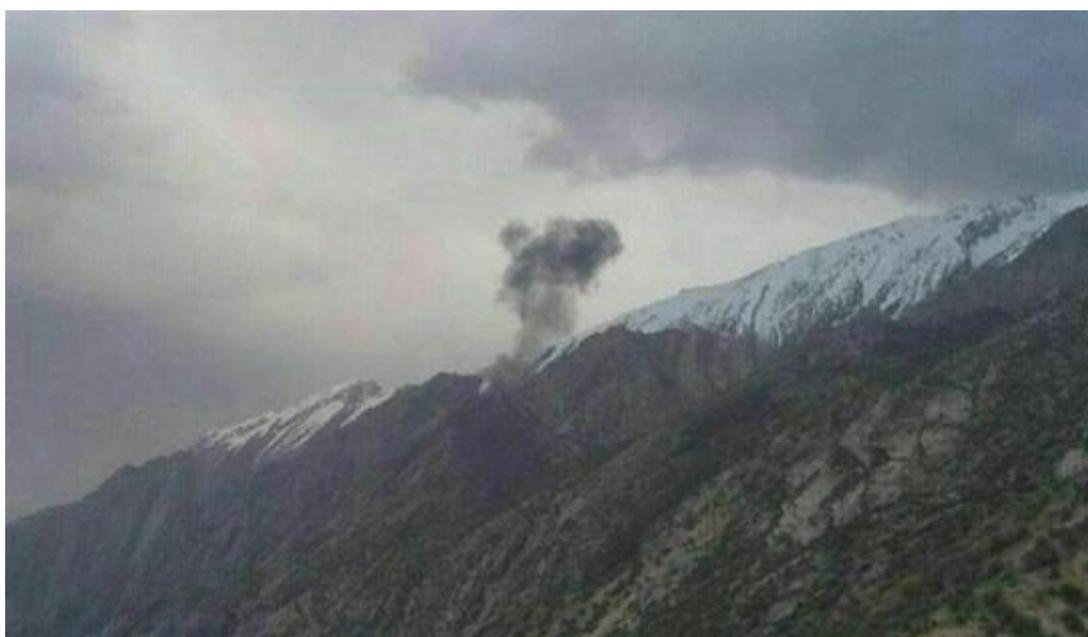
The first picture from crash site

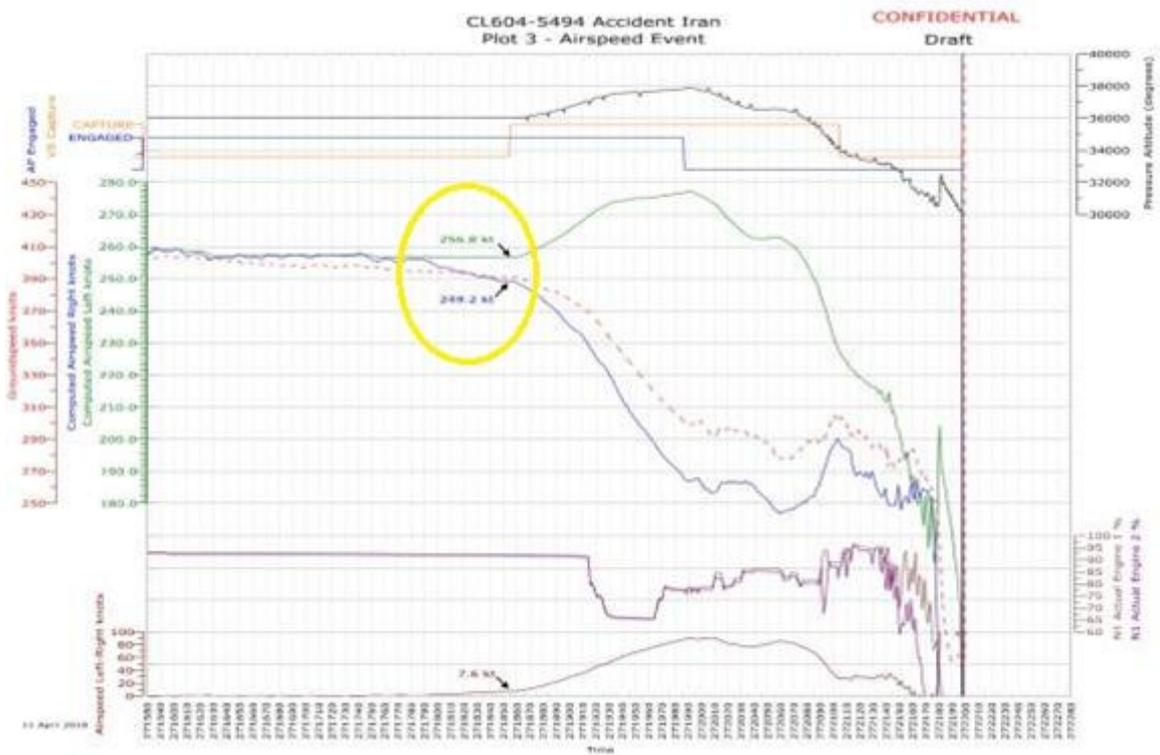
Accident flight

At 14:32 on FL360 the speeds of both side indicators began to diverge about 5 kt.
