This document is an English translation of the Final Report on the fatal accident involving the Boeing 747-412F aircraft registered TC-MCL that occurred on January 16th, 2017 at Manas International Airport, Bishkek, Kyrgyz Republic.

**INTERSTATE AVIATION COMMITTEE
AIR ACCIDENT INVESTIGATION COMMISSION**

**FINAL REPORT
ON RESULTS OF THE AIR ACCIDENT INVESTIGATION**

Type of occurrence	Fatal accident
Type of aircraft	Boeing 747-412F
Registration mark	TC-MCL
Owner	LCI Freighters One Limited (Ireland)
Operator	ACT Airlines
Aviation Authority	Directorate General of Civil Aviation of Turkey (Turkish DGCA)
Place of occurrence	Near Manas International Airport, Bishkek, Kyrgyz Republic, coordinates: N 43°03.248' E 074°2.271'
Date and time	16.01.2017, 07:17 local time (01:17 UTC), night time

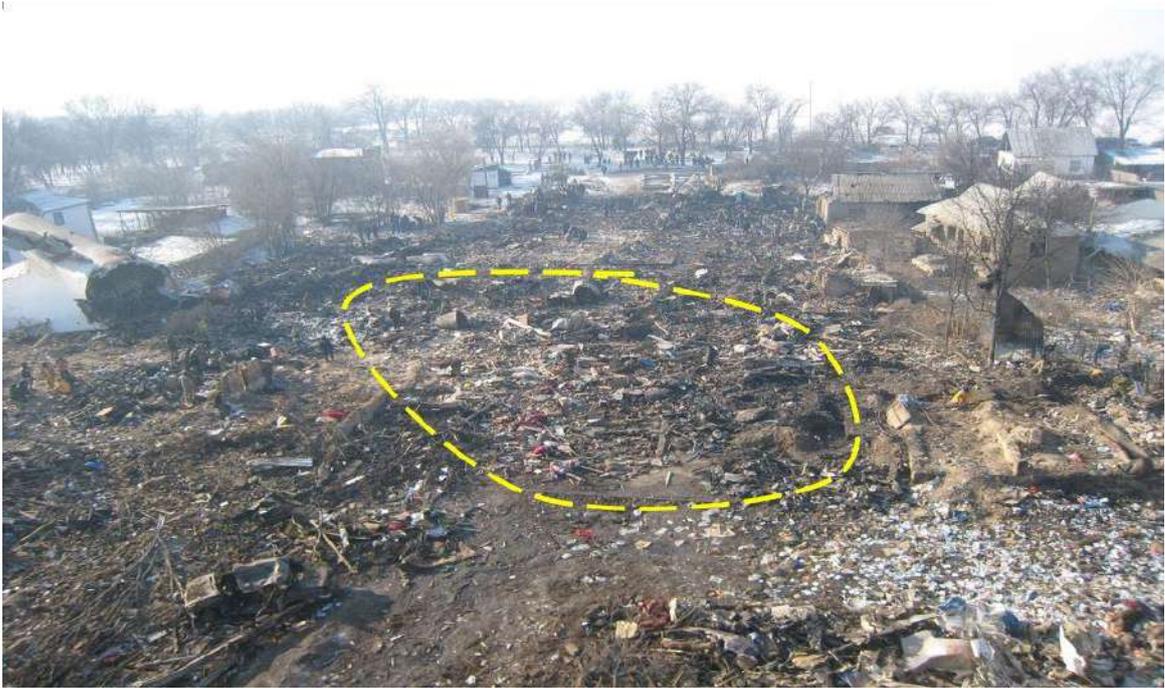
The ground fire bed is found in the central fuselage area on the line in-between the separated tail section and cockpit (Figure 1).

Figure 1. Main fire bed (indicated by yellow dashed line)

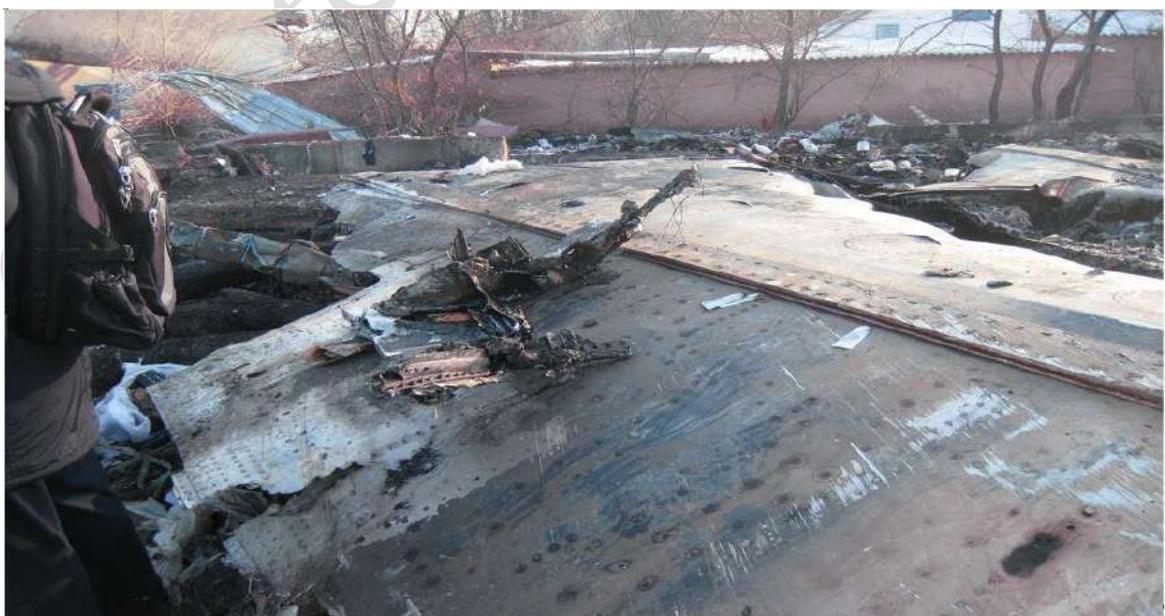
The RH wing section and the LH wing section disintegrated (Figure 2 and Figure 3).

Figure 2. RH wing fragment

The structural elements, mounting the RH wing section to the fuselage, have been destroyed by the off-design stress loads, and the LH wing mounting elements have been destroyed by the thermal impact. The central wing section has been destroyed by the fire.

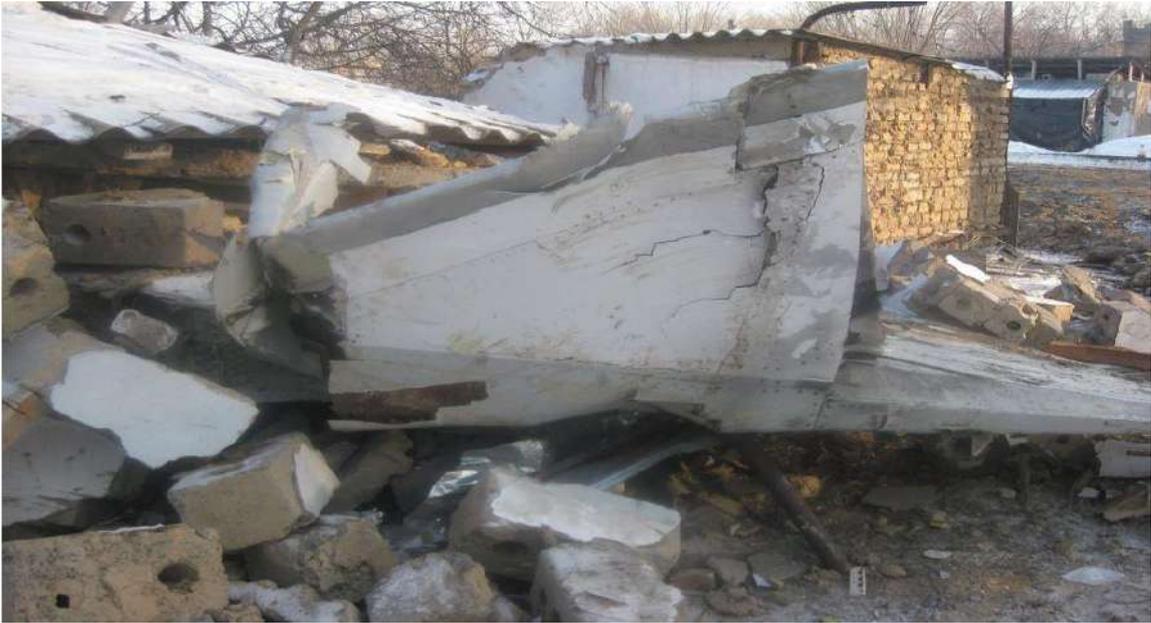
Figure 3. LH wing fragment

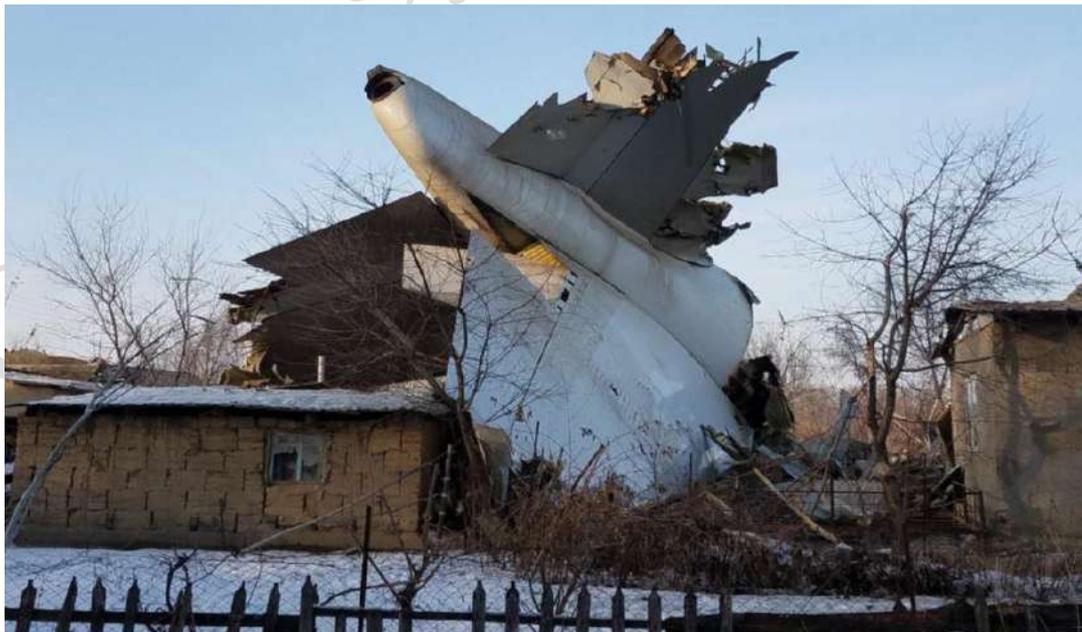
The fin and the horizontal stabilizer (Figure 4) have been found attached to the tail fuselage section, extending from the aft pressure bulkhead to the tail cone. The leading edges of the fin and the rudder show damage caused by the terrain impact. No traces of fire or soot have been found.

Figure 4. Tail fuselage section

The horizontal stabilizer fragment has remained in its standard position and has been found at the accident site in the turned-over position. The center box section, connecting the two parts of the stabilizer, the stabilizer trim drive mechanism and the jackscrew show no outer damage. The left part of the stabilizer and the elevator have been damaged as a result of the impact with the obstacles, part of the assembly is missing. The right part of the stabilizer has remained in its standard position and shows damage.

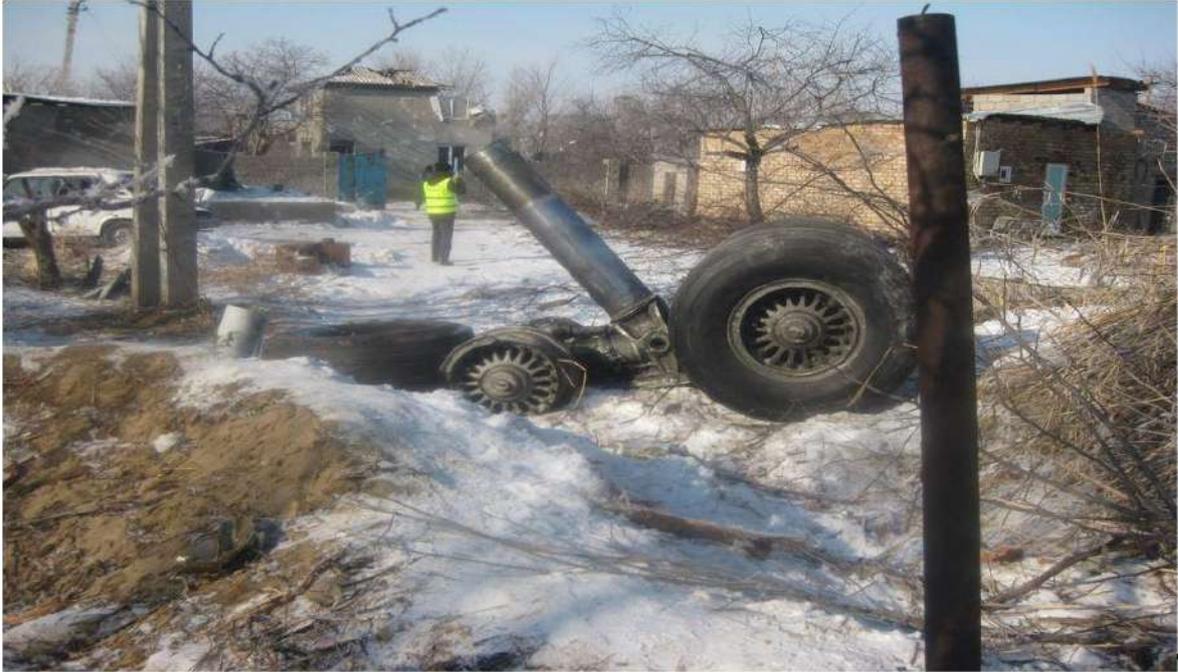
- the right body landing gear assembly has been torn off its mounting points and disintegrated. The rear wheels have remained attached to the gear bogie axle, the axle with the two forward wheels has been torn off and disintegrated into separate fragments (Figure 5);

Figure 5. Right wing gear

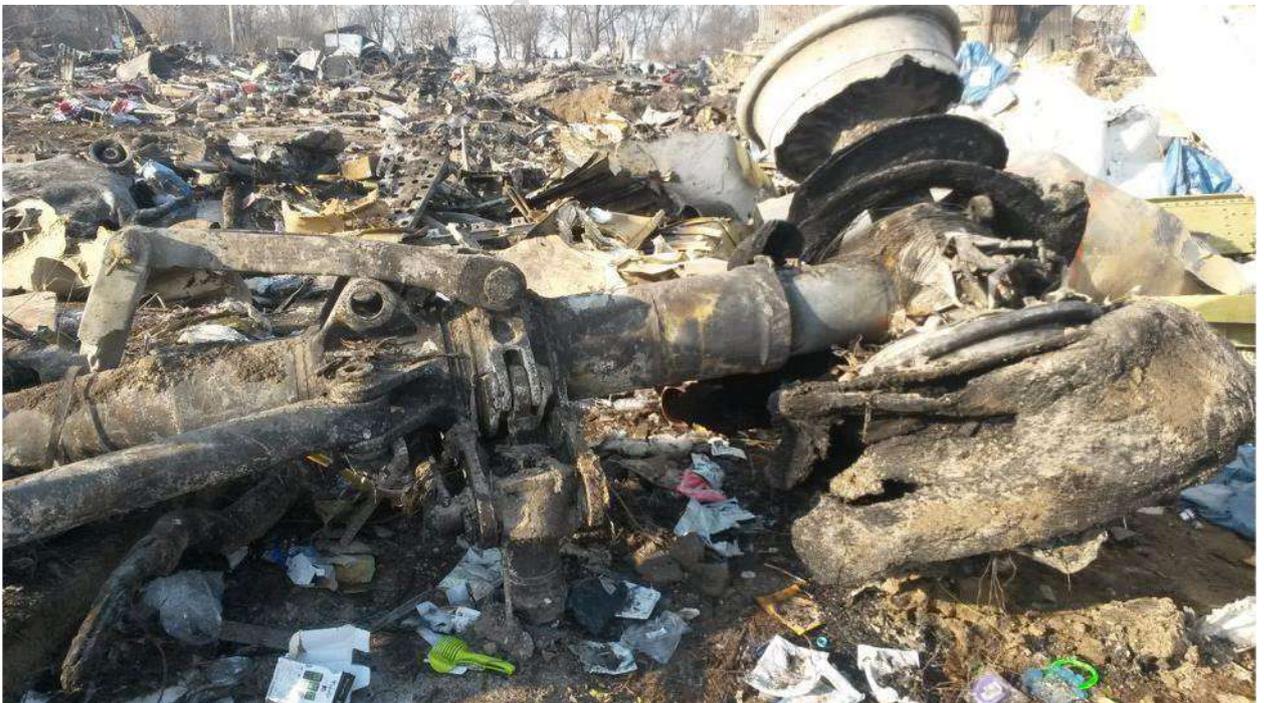
- the nose gear has been torn off its mounting points as a result of the impact with the obstacles. The hydraulic cylinder, the rods, the stays and wheel axle are found assembled, showing the traces of the thermal impact. The wheel tyres have been destroyed by the fire. The position of the gear extension/retraction hydraulic cylinder rod (the rod is in the extended position) indicates that the landing gear was in the extended position. (Figure 6).

Figure 6. Nose landing gear

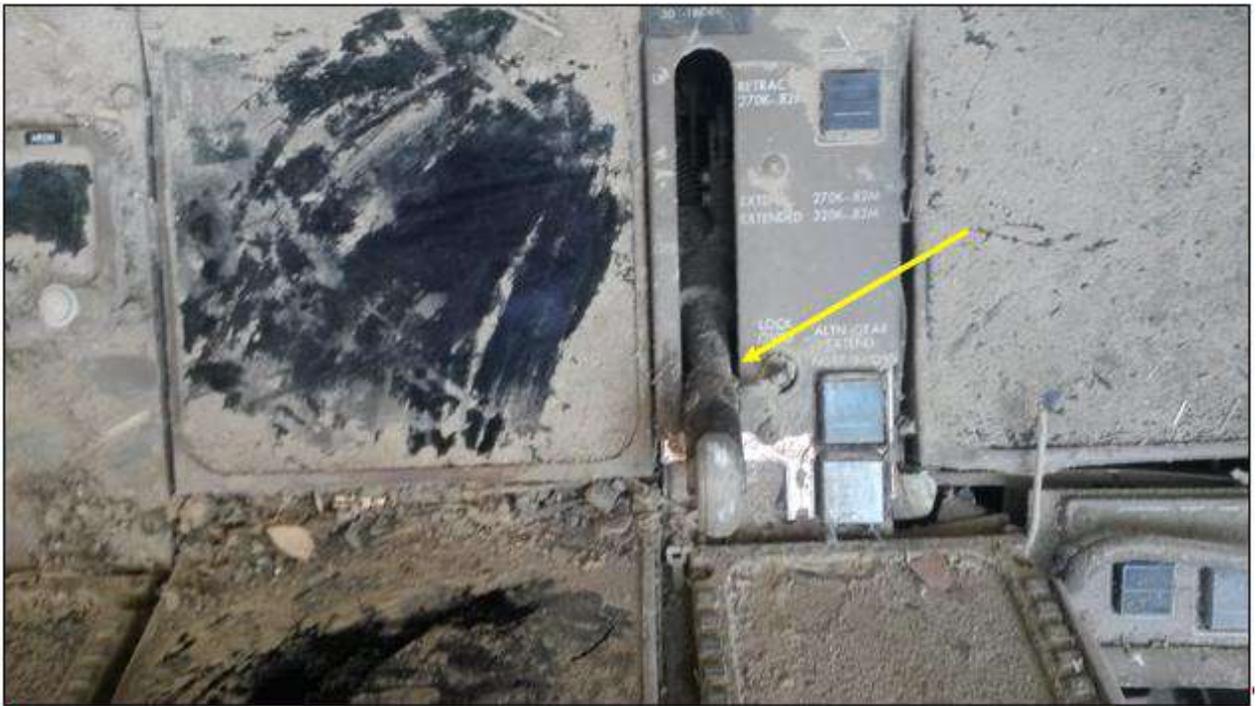
The landing gear extension/retraction control lever in the cockpit is found in the position, which corresponds to the extended gear position (Figure 7, indicated by the arrow)

Figure 7. Landing gear extension/retraction control lever

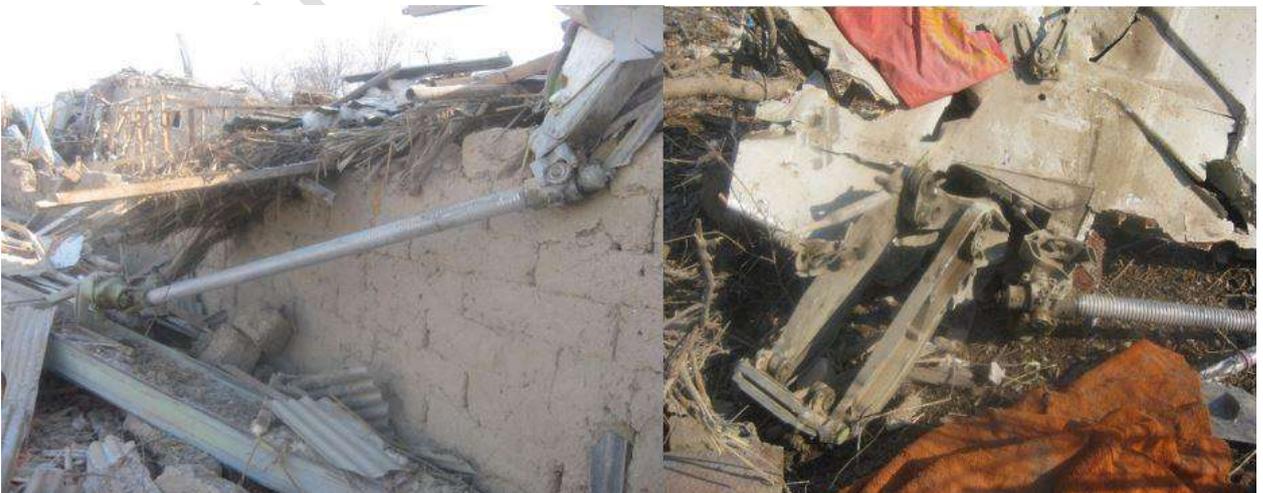
At the time of the accident, the wing flight control surfaces were in the landing configuration, which is confirmed by the positions of ball-screw assemblies of the leading and trailing edge flaps (the surfaces have been found in the fully extended positions (in the mechanical stop positions)) (Figure 8), as well as by the position of the flap control lever (Figure 9).

Figure 8. Ball-screw assemblies' positions

All the 8 ball-screw assemblies of the flap extension/retraction system (4 for each of the both outer wing sections) have been found. The shafts' positions in relation to the ball-screw nuts (thread turns) indicate that the flaps were at 30°.

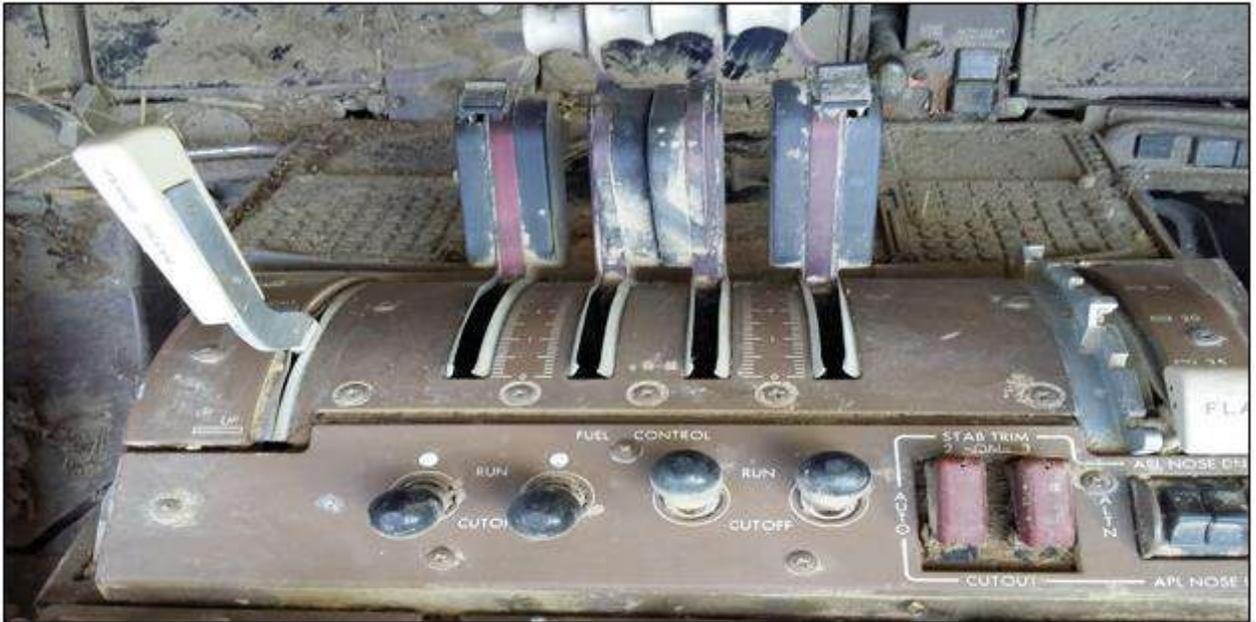
Figure 9. Flap control lever

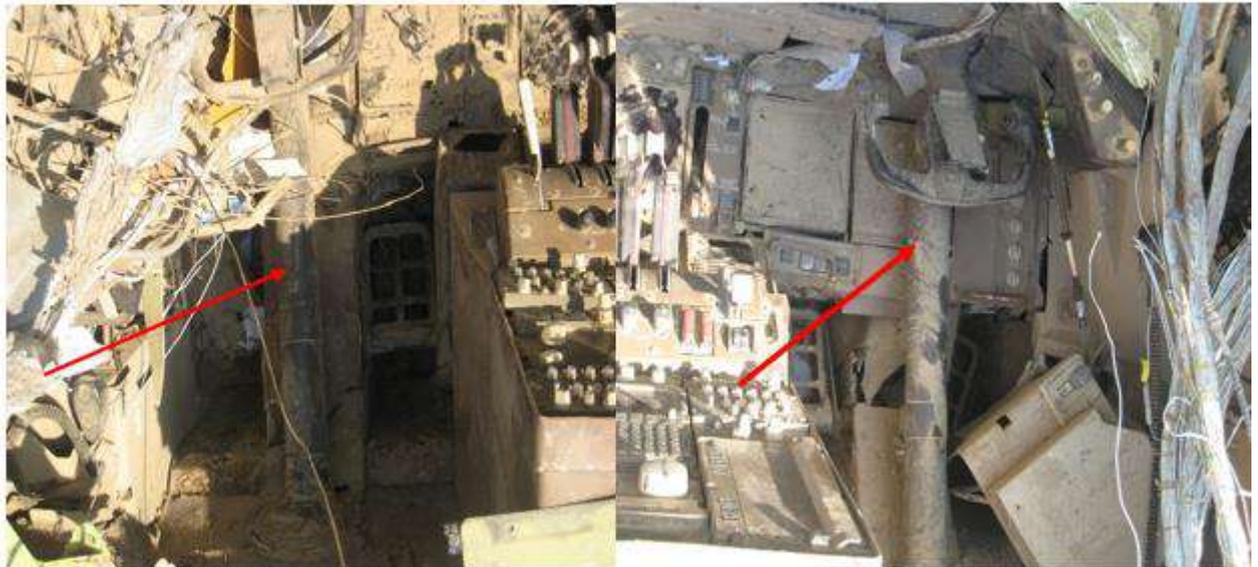
During the cockpit inspection, no visual damage of the PIC's and FO's control columns has been found (Figure 10).

Figure 10. Pilots' control columns (indicated by arrows)

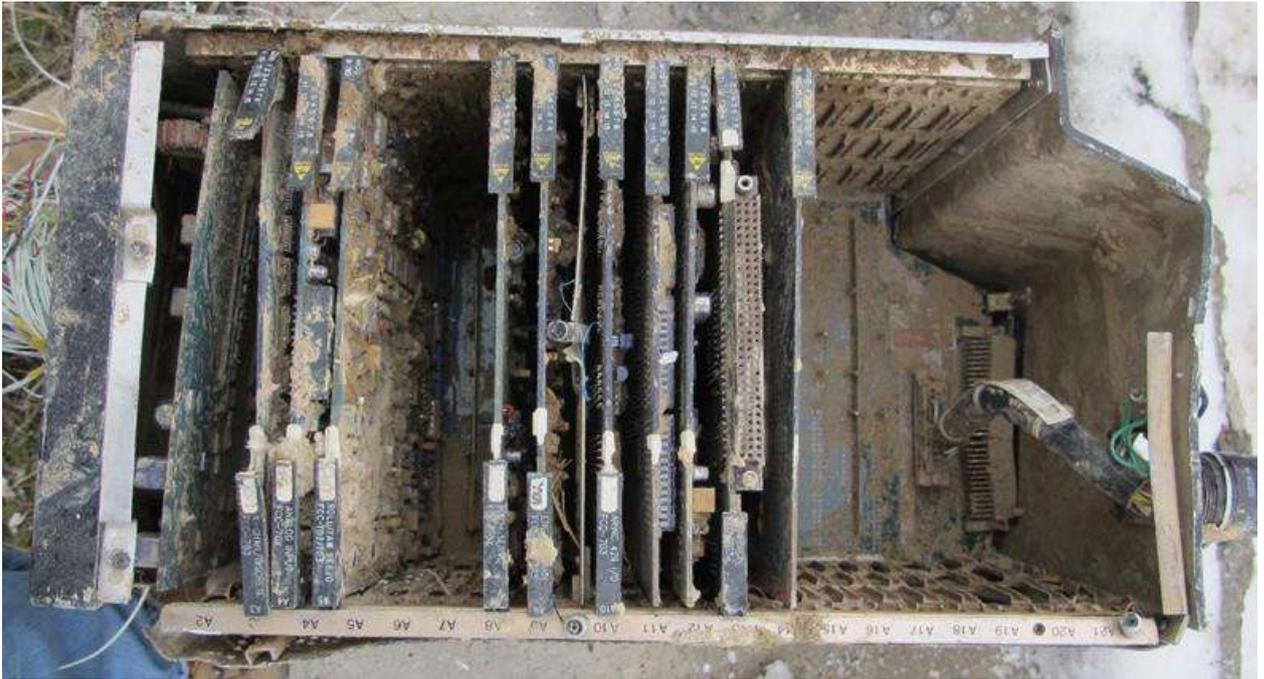
- the three damaged Flight Control Computers (FCCs), electronic circuit boards have remained on one of the units (Figure 11);

Figure 11. FCC unit with remaining electronic circuit boards

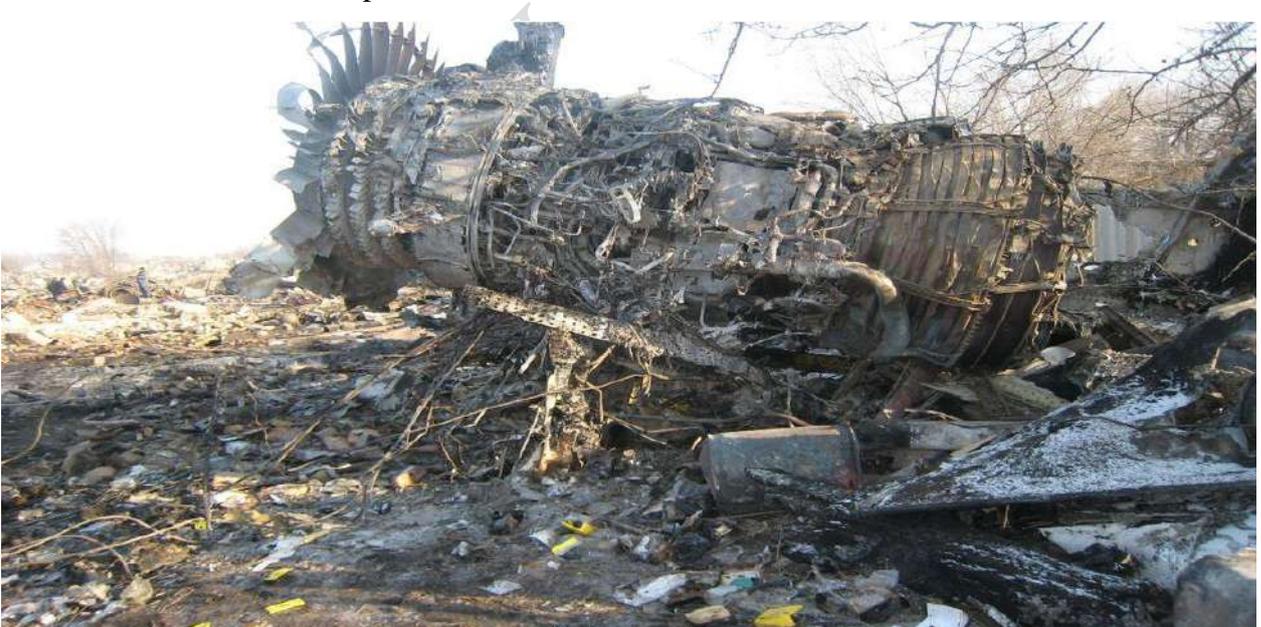
Engine No.1 (Figure 13) has been found burnt-out due to the post-crash ground fire which occurred after the terrain impact.

Figure 13. Engine No.1

The inlet cowl, the [other] engine cowling sections and the exhaust nozzle of Engine No.1 have been found torn-off and destroyed. The fan section of the cowling has been completely destroyed. The fan blades, the low pressure compressor (LPC) have been destroyed and show

traces of melting. The accessory gearbox casing has been destroyed: the engine-mounted units (the IDG, the starter) have been torn off, significantly damaged and burnt out. The high pressure compressor (HPC) and the combustion chamber have been damaged. The turbine section of the cowling, the turbine case cooling system and the related fittings have been deformed and melted. The low pressure turbine blades are melted. The engine shaft shows traces of twisting and has been torn off.

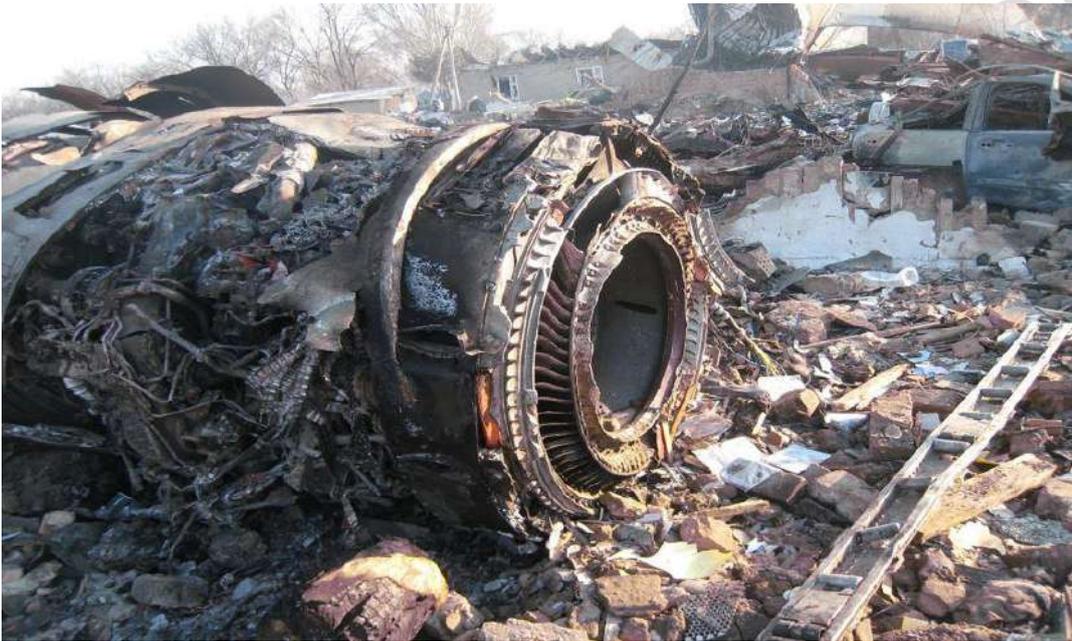
Engine No.2 has been completely destroyed (Figure 14).

Figure 14. Engine No.2

The inlet cowl, the [other] engine cowling sections and the exhaust nozzle of Engine No.2 have been torn-off as a result of the aircraft impact with the concrete aerodrome barriers and other obstacles (trees and buildings) as well as due to the terrain impact. The fan cowling section has been completely destroyed. The fan blades have been destroyed and show traces of melting. The accessory gearbox casing has been destroyed due to the thermal impact. The HPC and the combustion chamber have been deformed. The turbine cowling section and the stator vanes have been significantly damaged. The units located on the fan cowling section as well as the engine manifolds, units and wiring have been burnt out.

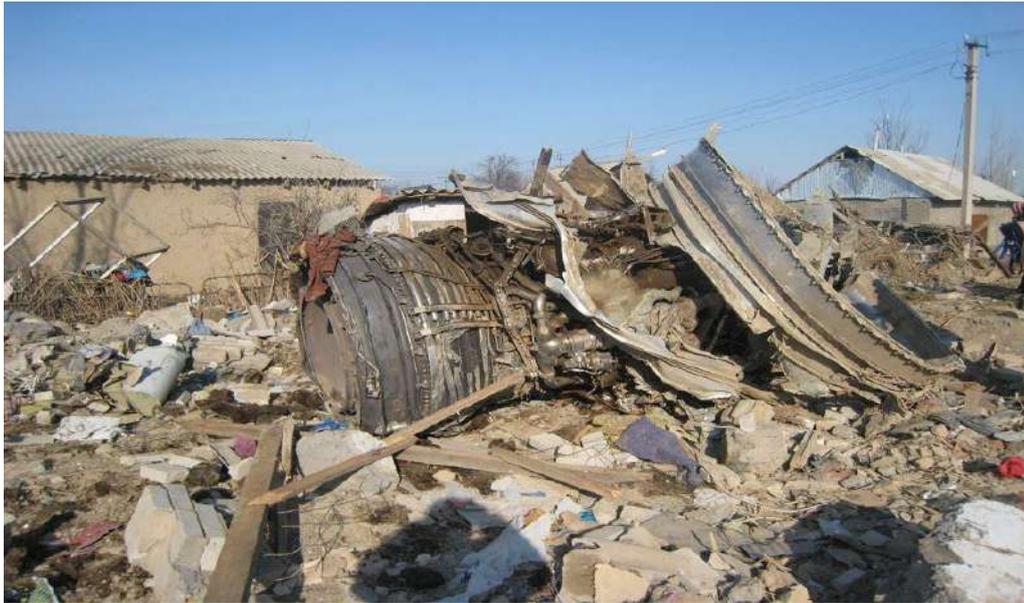
Engine No.3 has been completely destroyed due to the impact with the obstacles and the terrain (Figure 15).

Figure 15. Engine No.3

The inlet cowl and the [other] engine cowling sections of Engine No.3 have been torn-off and scattered over the accident site. The inlet cowl has disintegrated. The fan blades have been twisted and torn off, which confirms the fact that the turbines were driving the fan section during the impact with the obstacles. The LPC blades have also disintegrated. The combustion chamber has no visual damage. The units and fittings, mounted on the accessory gearbox, have been significantly damaged. Some of the LPT blades have disintegrated. The exhaust nozzle and sleeve have been torn off.

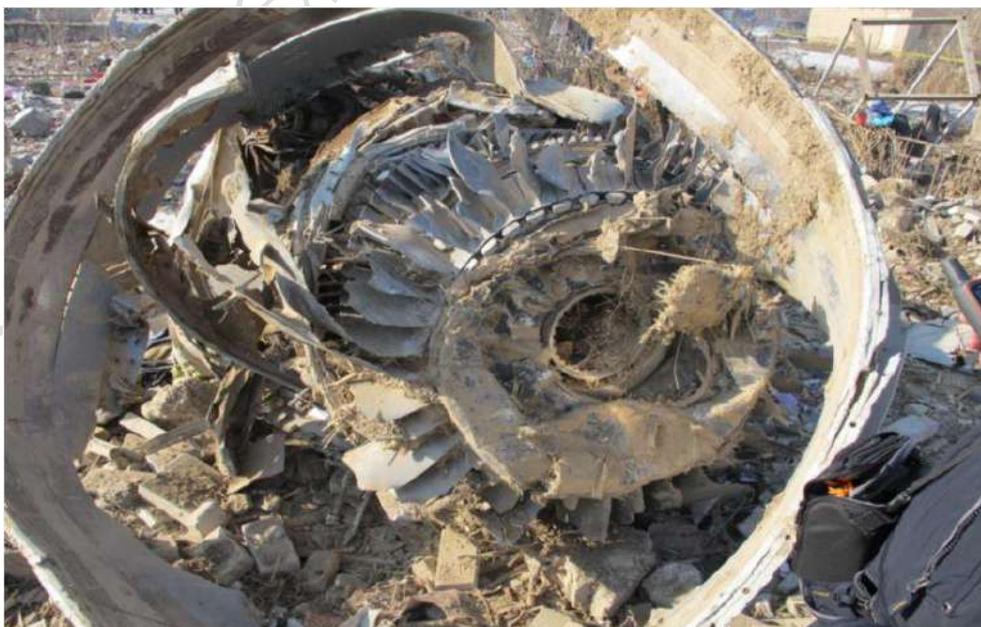
Engine No.4 has been destroyed due to the aircraft impact with the obstacles. (Figure 16).

Figure 16. Engine No.4

The inlet cowl and the [other] engine cowl sections of the engine have been torn-off and scattered over the area of the accident site. The inlet cowl has disintegrated. The fan blades have been twisted and torn off, which confirms the fact that the turbines were driving the fan section at the time of the impact with the obstacles. The LPC blades have disintegrated. The combustion chamber has no visual damage. The units, mounted on the accessory gearbox, and the related fittings have been significantly damaged. Some of the LPT section casing and blades have disintegrated. The exhaust nozzle and sleeve have been torn off.

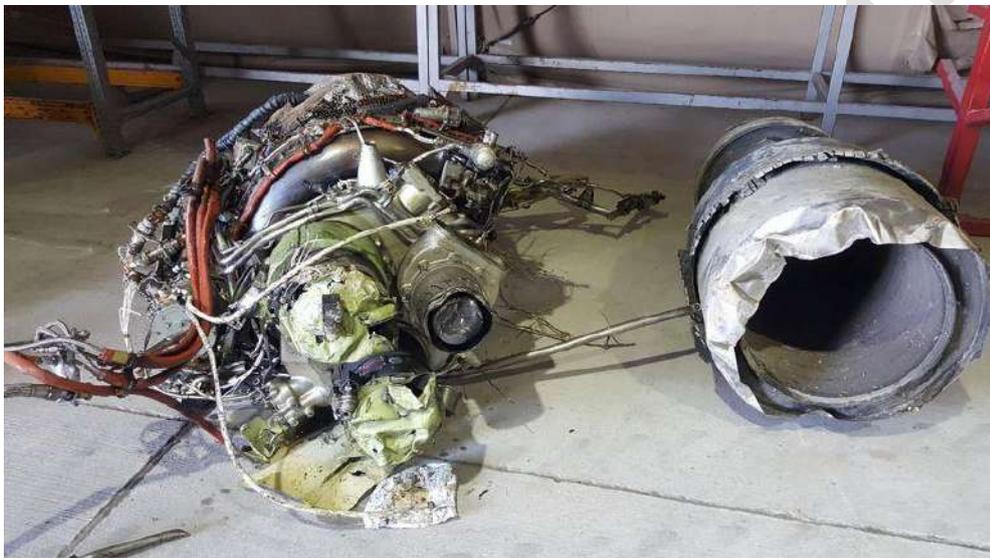
Within the separated tail fuselage section, the partially deformed APU as well as the APU casing have been found (Figure 17).

Figure 17. Dismantled APU with APU exhaust nozzle

The APU has been found in its standard mounting place. The fuel supply lines and the wiring, running to the APU, have been torn off and destroyed.

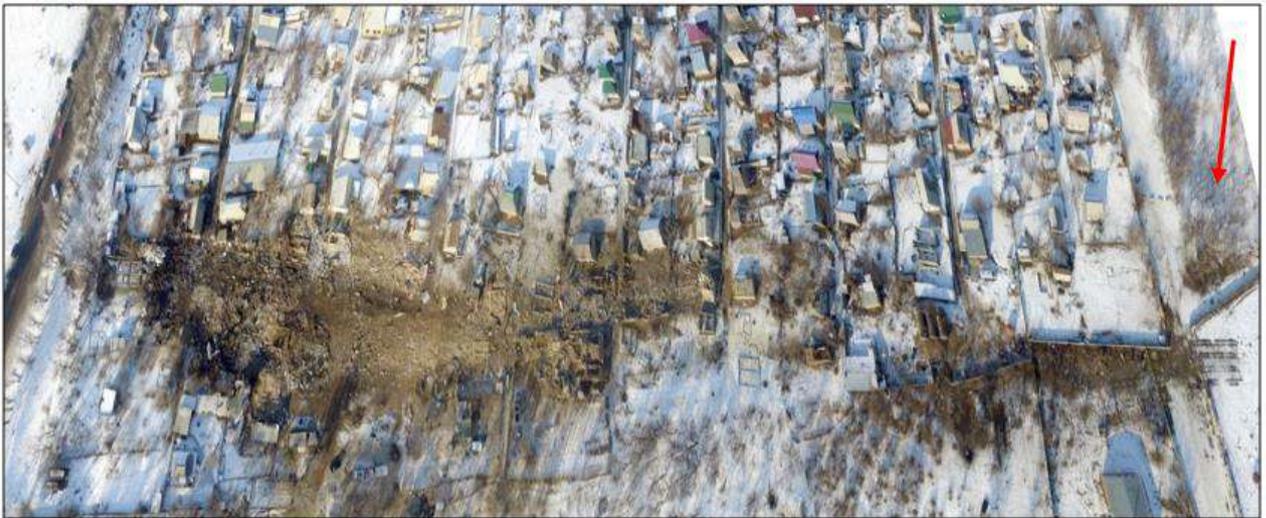
The accident site (Figure 25) is an area with the damaged or destroyed houses extending for the length of approximately 550 m and for the width of 40 – 60 m.

Figure 25. General accident site overview (photo made by drone, arrow indicates first touchdown point)

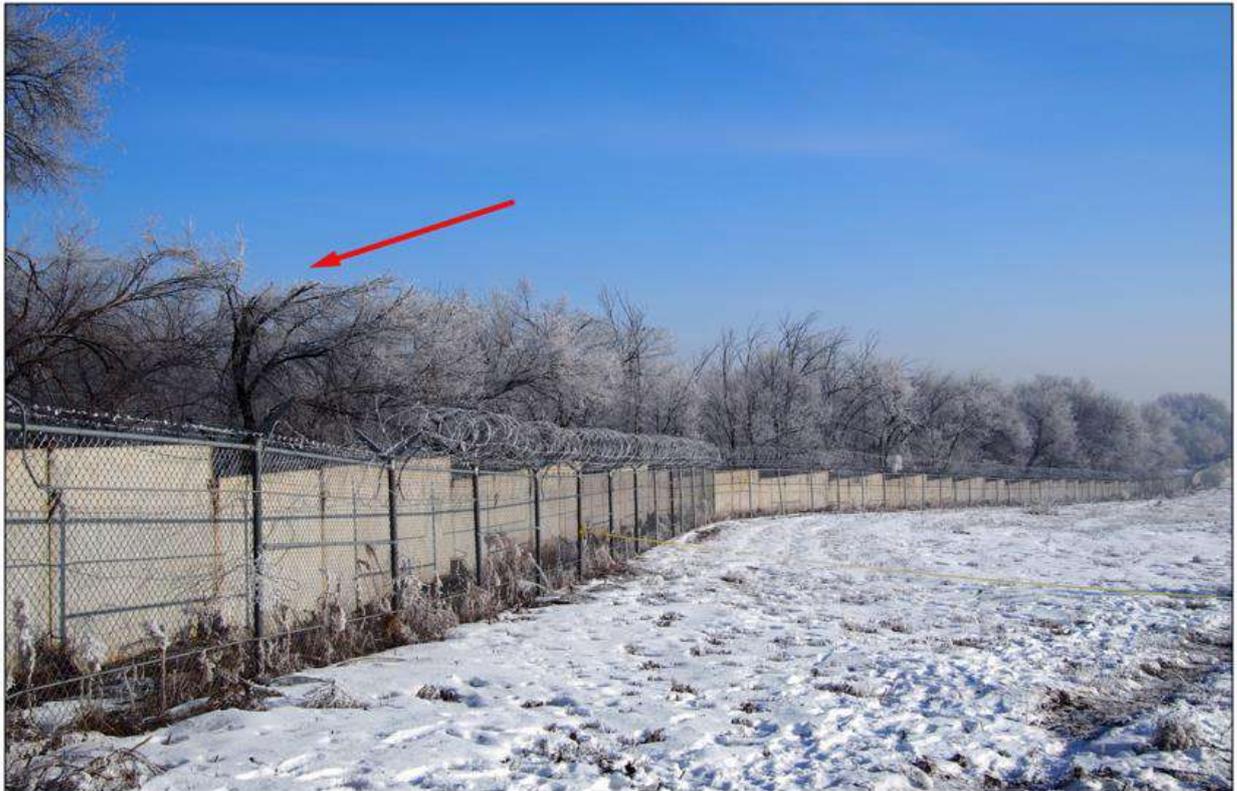
Prior to the aircraft touchdown, the aircraft RH wing tip impacted the tops of the trees, which were located to the right of the aircraft trajectory and looking towards the direction of the trajectory (Figure 26).

Figure 26. Trees damaged by aircraft RH wing tip (indicated by arrow)

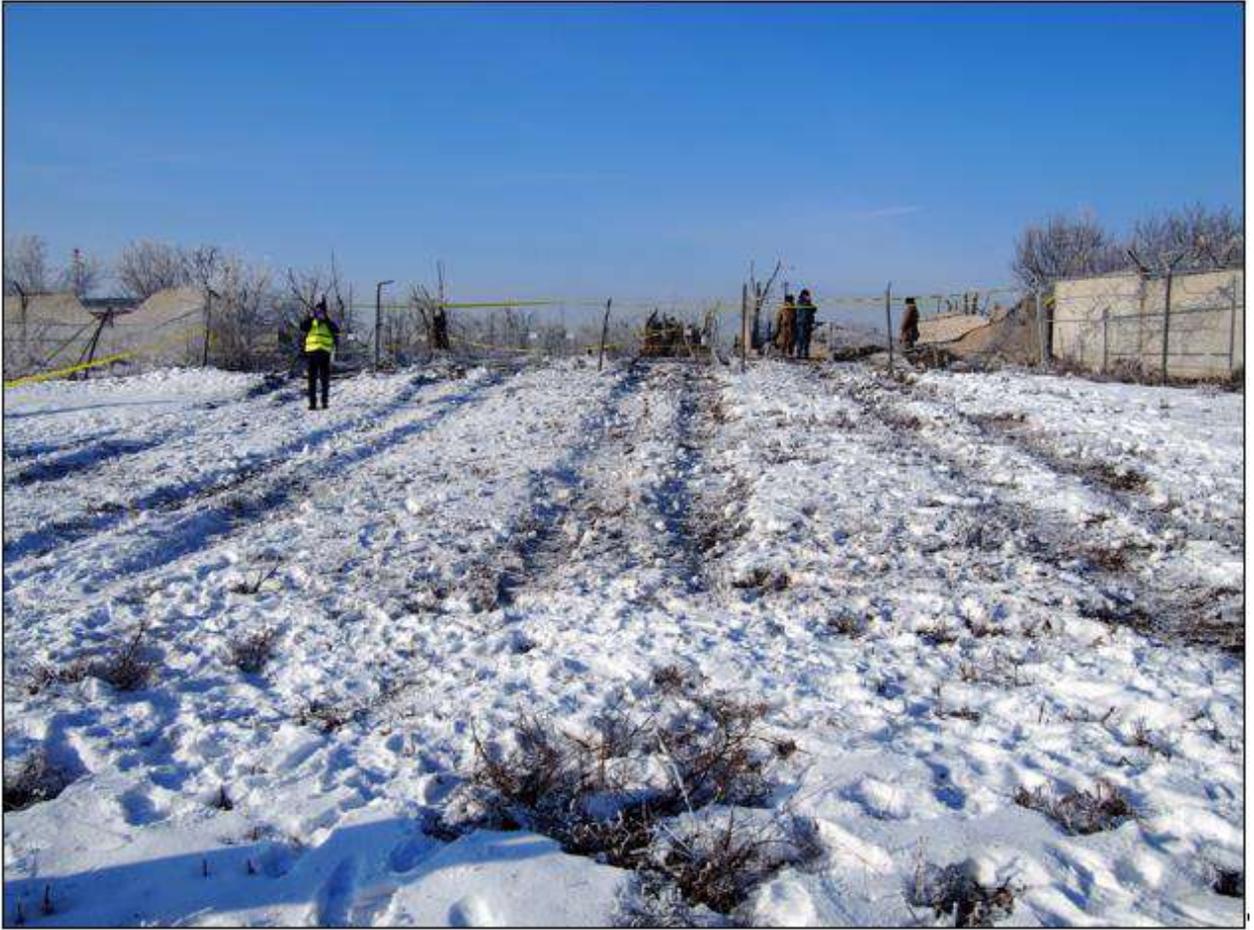
The character of the first touchdown traces indicates that the first aircraft terrain touchdown occurred at an insignificant vertical speed and almost without any bank angle. The aircraft heading at the beginning was very close to the landing heading of 255° . At the area where the aircraft was moving on the ground surface, no marks of the nose landing gear wheels have been found, which indicates that the aircraft was having a positive pitch angle at the touchdown. The aircraft movement after the first touchdown was straightforward (Figure 27).

Figure 27. Main landing gear wheel traces at first touchdown place

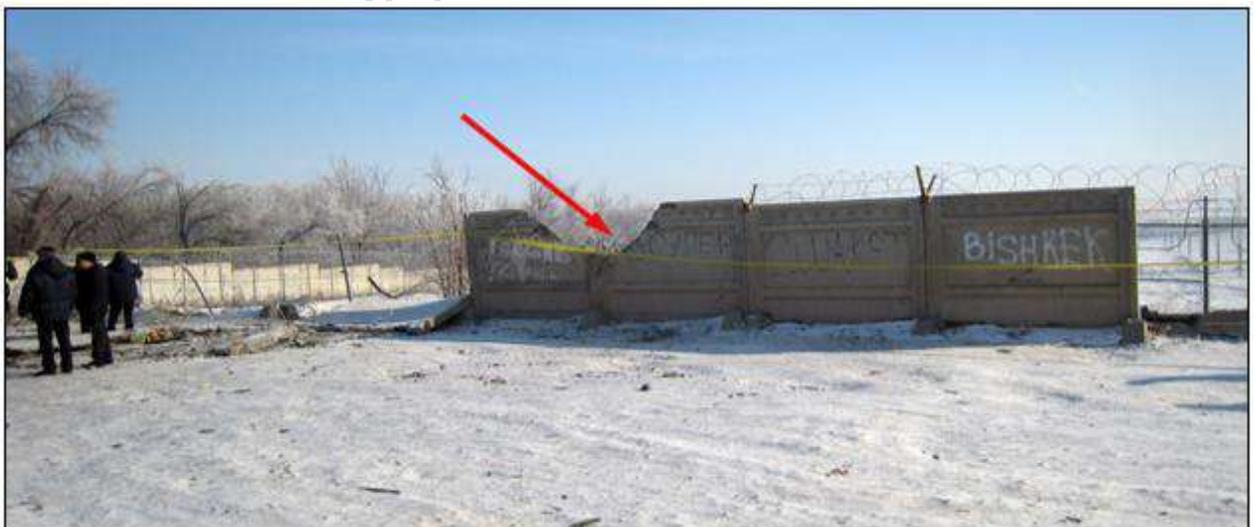
After 20 m of movement along the ground surface, the aircraft impacted the concrete aerodrome barrier and destroyed it (Figure 28). Judging by the marks on the area, after the impact with the concrete barrier, the aircraft lifted off the ground surface for a short period of time.

Figure 28. Trace of LH wing engine impact with aerodrome barriers (indicated by arrow), view taken in direction opposite aircraft movement

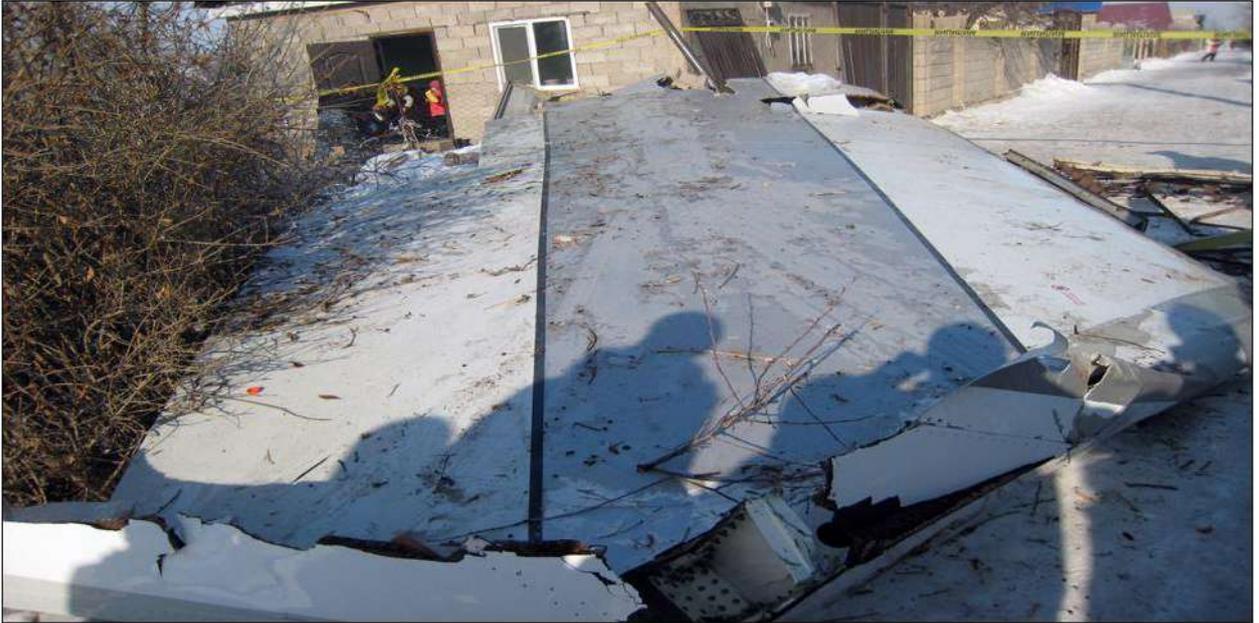
At the distance of approximately 160 – 170 m from the first touchdown place, the second terrain touchdown occurred. The aircraft impacted the buildings with its RH wing and engines No.3 and No.4. The RH wing tip with the winglet as well as small RH wing fragments were found in this area (Figure 29).

Figure 29. RH wing tip with winglet

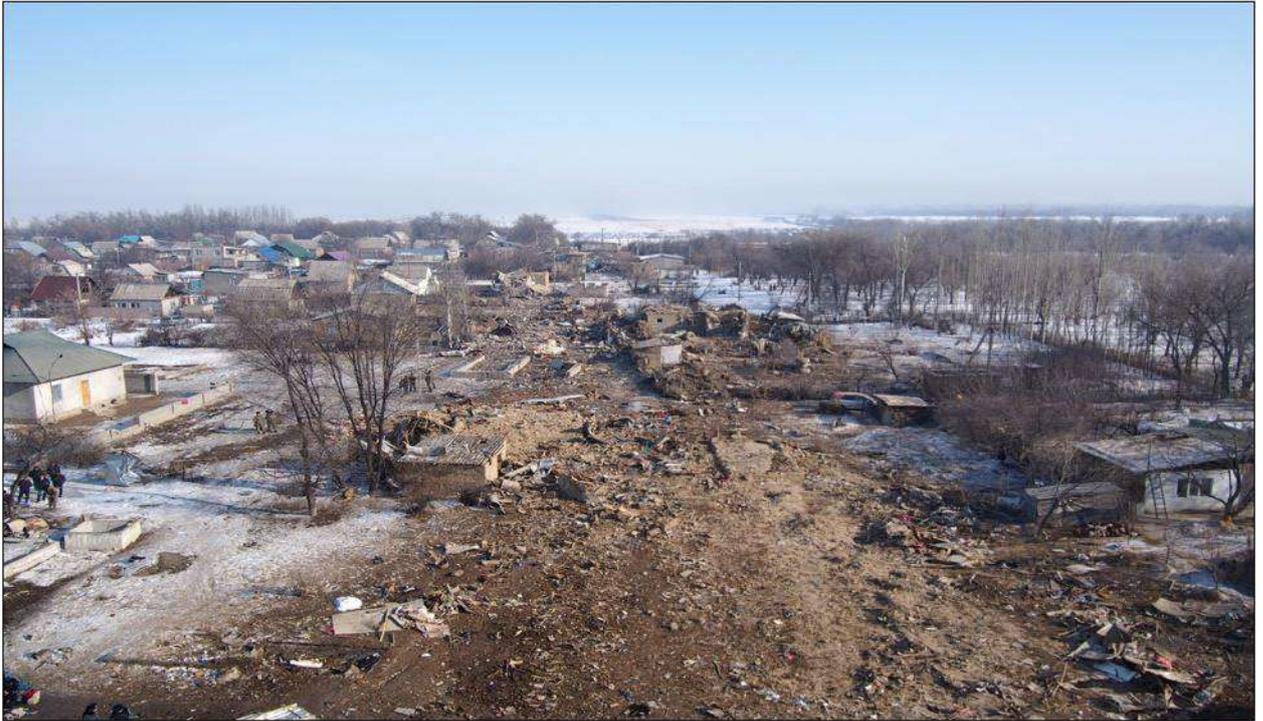
The aircraft movement along the ground surface still was of a straightforward character. The aircraft was moving forward with its LH side at the front, touching the ground with its lower fuselage. As a result, almost all the buildings, located in this area, were completely destroyed (Figure 30).

Figure 30. General overview of accident site

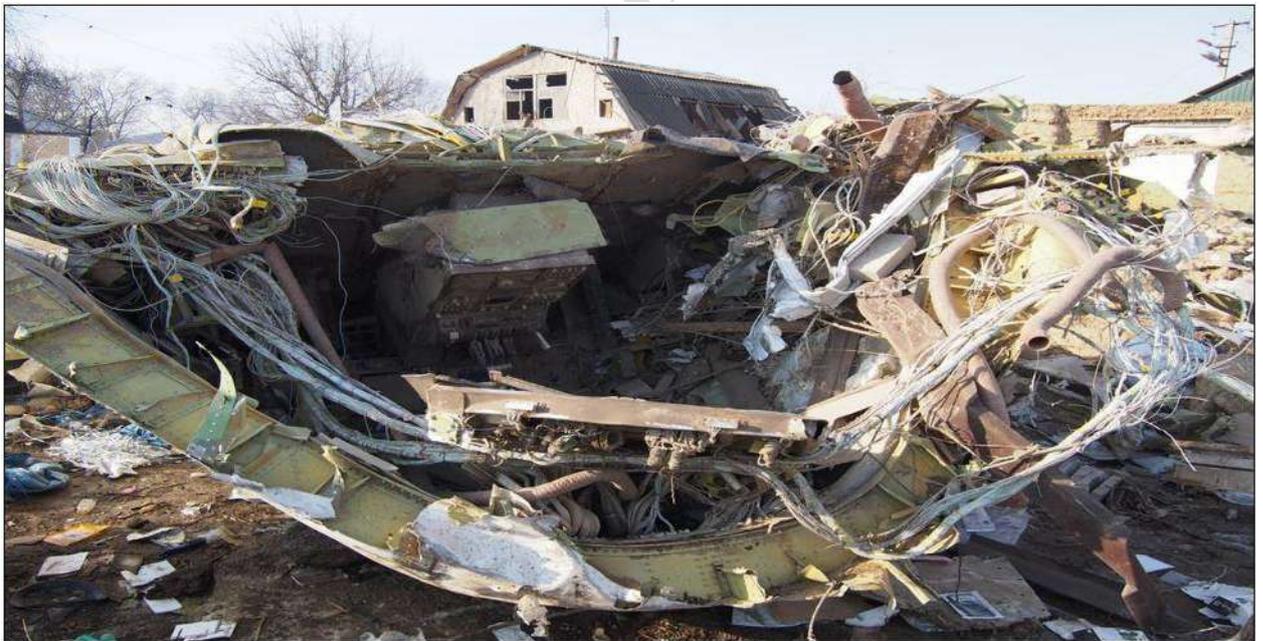
At a distance of ≈ 440 m from the place of the first touchdown, the aircraft cockpit impacted a brick house. The aircraft turned to the right to an angle of more than 90° , the aircraft fuselage was destroyed and the cockpit was torn off (Figure 31).

Figure 31. Main fragment of cockpit

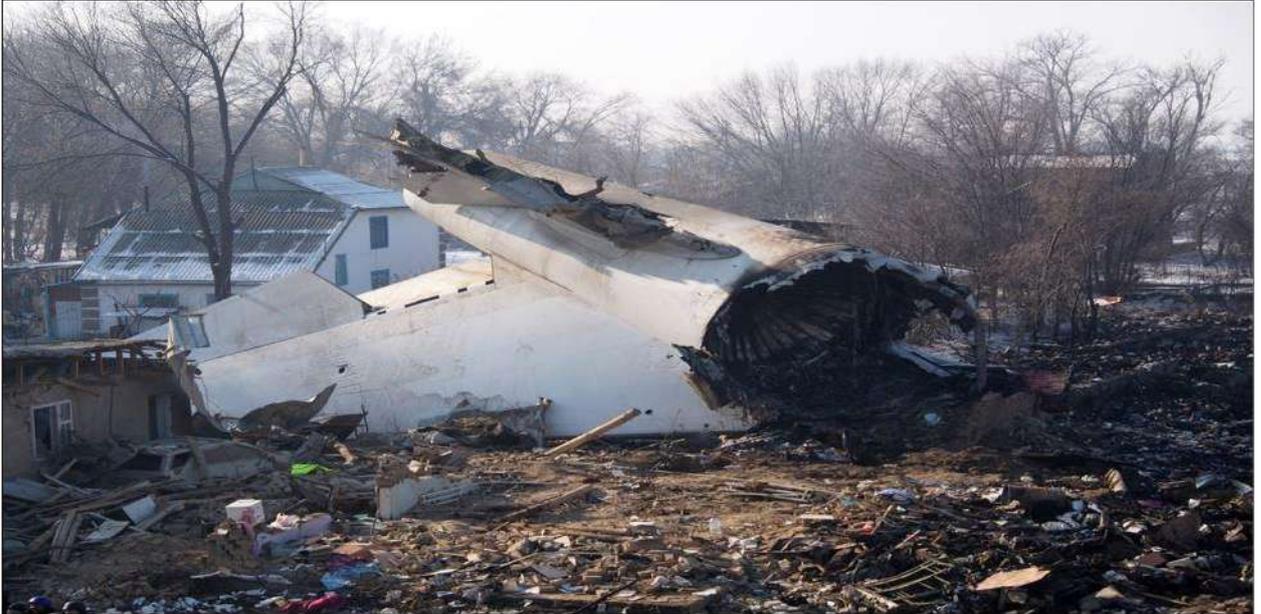
The aircraft movement stopped completely ≈ 60 m away from the cockpit separation place. The tail section of the aircraft (Figure 32) and a big fragment of the LH wing with the traces of fire (Figure 33) have been found ≈ 470 m away from the place of the first terrain touchdown.

Figure 32. Tail fuselage section
