*Final Report on the accident of ATR72/212A version 500 (Registration:9N-ANC) that occurred on
January 15, 2023 near Pokhara International Airport*

GOVERNMENT OF NEPAL
AIRCRAFT ACCIDENT INVESTIGATION COMMISSION

FINAL REPORT

**9N-ANC (ATR 72-212A, MSN : 754) AIRCRAFT OPERATED BY YETI AIRLINES PVT.
LTD OCCURRED AT
POKHARA (AT THE BANK OF SETI RIVER - GHARIPATAN), KASKI DISTRICT, NEPAL ON
15 JANUARY 2023**

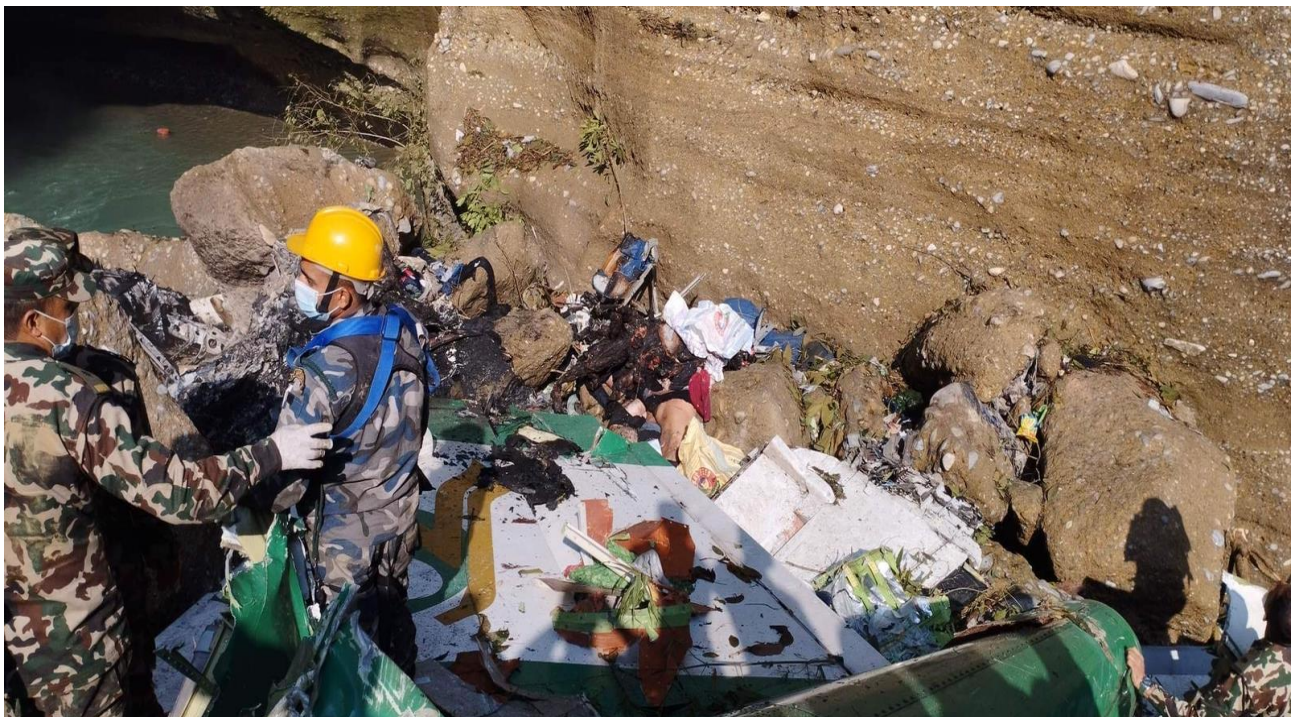
Figure 6 Wreckage within the gorge

The aircraft was completely destroyed due to the impact and post impact fire. Most of the fuselage structure, engines and its components were consumed by the fire. The propeller blades were found damaged, detached from the engine at various locations near the point of first impact. The wreckage was located at a gorge on the bank of the Seti Gandaki River and around the bank.

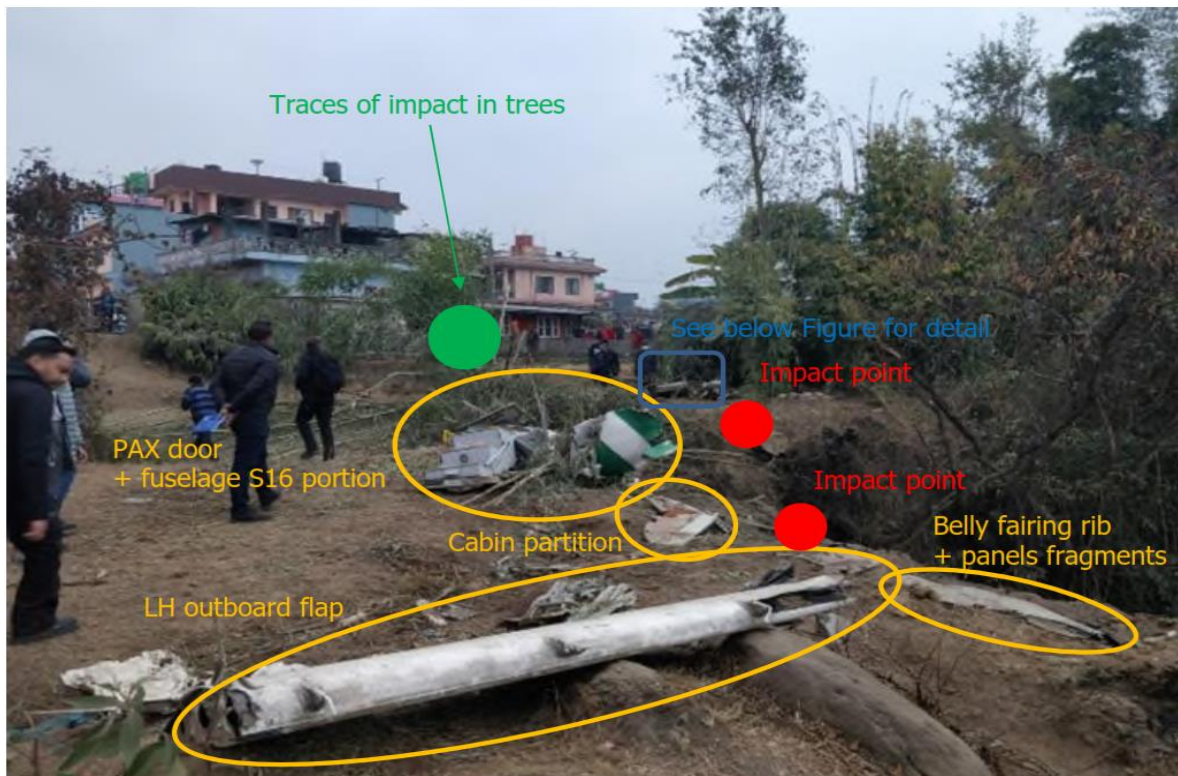
Figure 13 Site A- Identified impact points and parts

Site A: identified aircraft impact points plus aircraft parts such as PAX door and LH outboard flap, miscellaneous belly fairing panels and cabin partition, LH outer wing box, panel segment, leading edge, LH aileron tip and portion of aileron box.

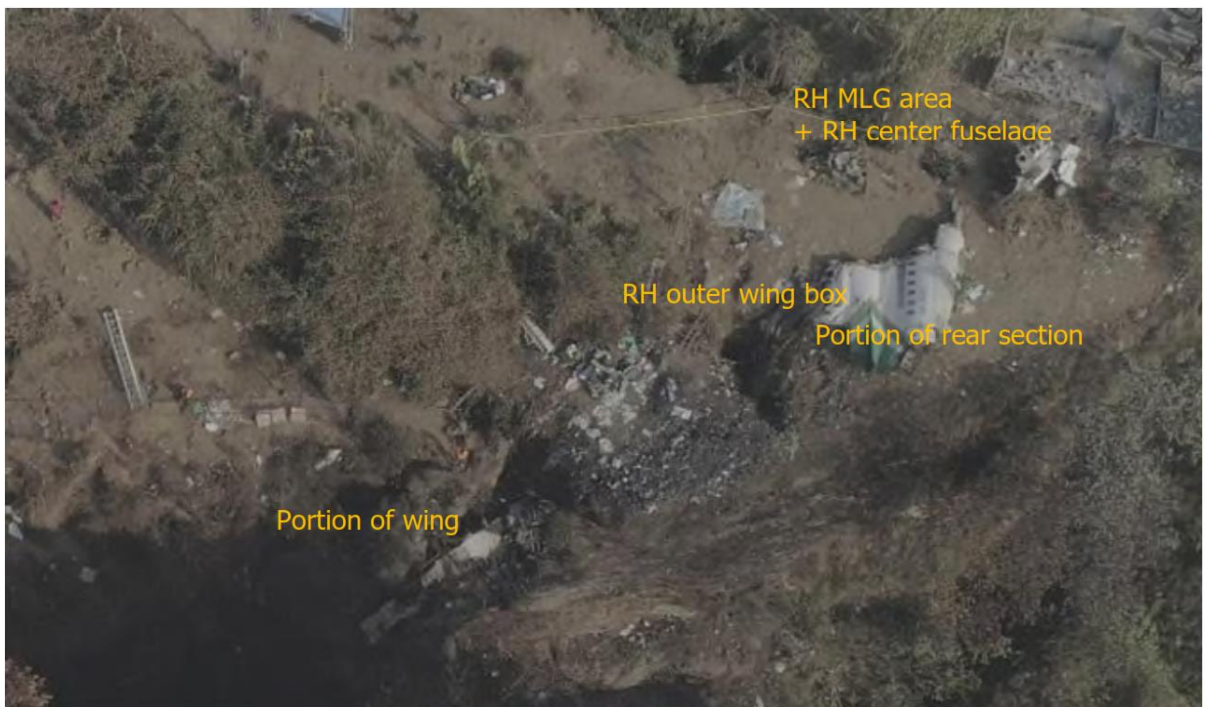
Figure 16 Blown up aerial view of components in Site B

Site B – identified rear section, RH MLG area, portion of wing (RH side plus LH/center upper area) and RH outer wing box plus miscellaneous cabin/seats items, portion of wing/nacelle/engine (RH side plus LH/center upper area), plus fragment from LH MLG shock absorber.

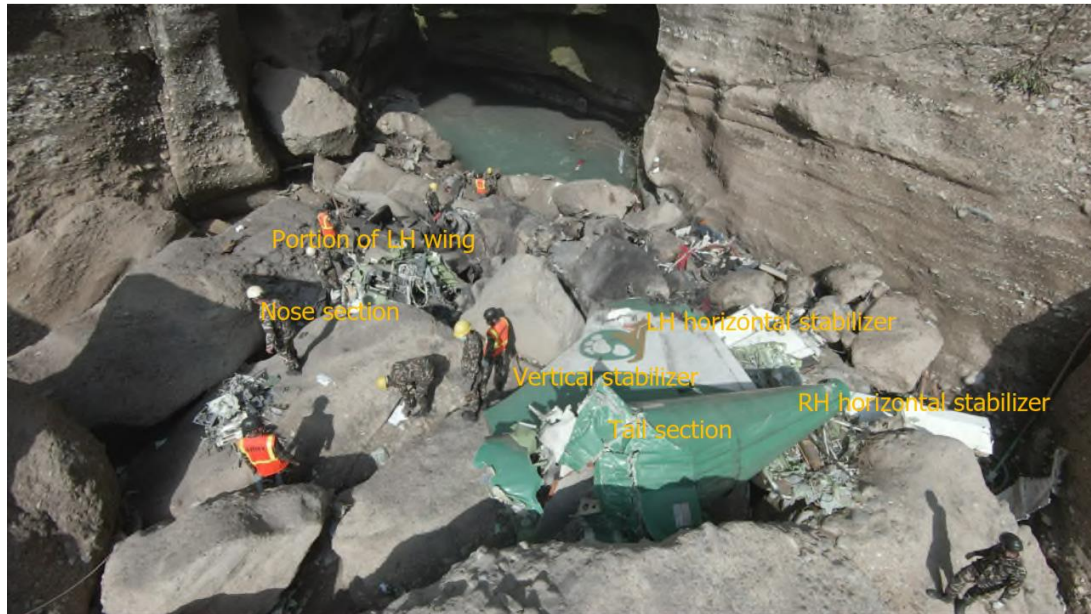
Figure 17 Wreckage identified at Site C

Site C – showing identified tail section, vertical and horizontal stabilizers, portion from LH wing/nacelle/engine/propeller plus portion of nose fuselage/cockpit, nose section and cockpit indicators.

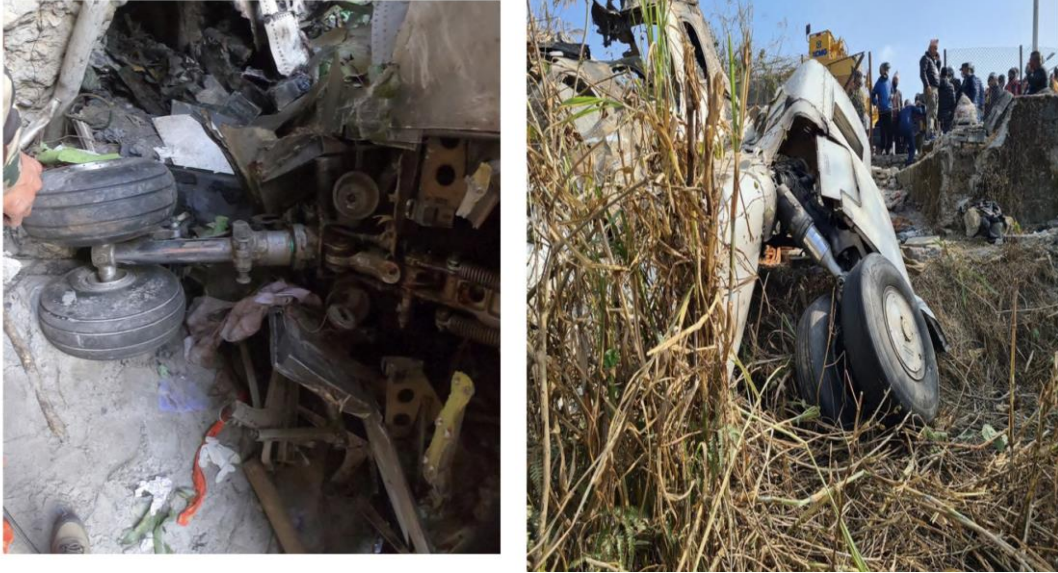
Figure 19 Landing gears

Landing gears were detached from the main body. They were moved from their original positions during search and rescue process.

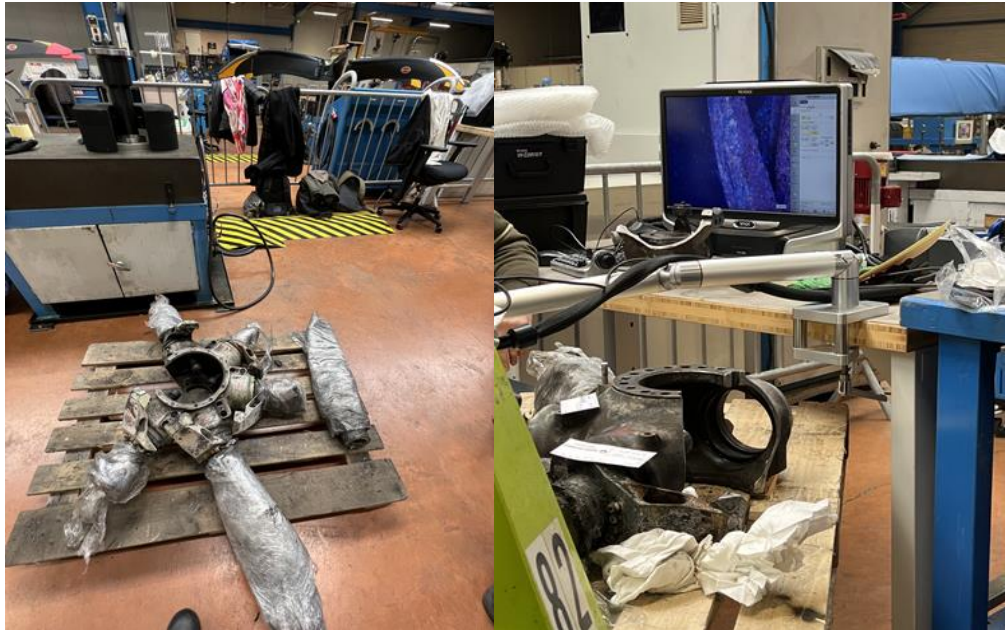
Figure 22 Propeller hub and blades examination at Figeac, France

"Most of the blades on the RH propeller hub were observed to be in feathered position; however, the indices were slightly less obvious on the LH propeller hub. Two blades on the LH hub were in line with the feather setting while the other blades were free around their pitch change axes. The position of the actuator was not at the expected position for feathered propeller, but the actuator could have moved upon impact."

Of the six propeller blades, two of them (4 and 5) were found stuck in a position where the counterweight arm was close to the plane of rotation, therefore in a position close to that of the flag. Damage to the hub to the right of blade 5 due to the counterweight of this blade was also noted. The repositioning of the counterweight in relation to this damage was also noted. The repositioning of the counterweight in relation to this damage corresponded to a blade close to the flag position. The other blades were partially free to rotate around their axis. The pitch change device piston (located in the centre of the hub) was slightly offset from the position corresponding to that of the flag.

The blades were all in a position where the counterweight arm was close to the plane of rotation, therefore in a position close to that of the flag. Two blades (1 and 4) were stuck in this position while the other blades were free to rotate. The pitch change device piston (located in the center of the hub) was slightly offset from the position corresponding to that of the flag.

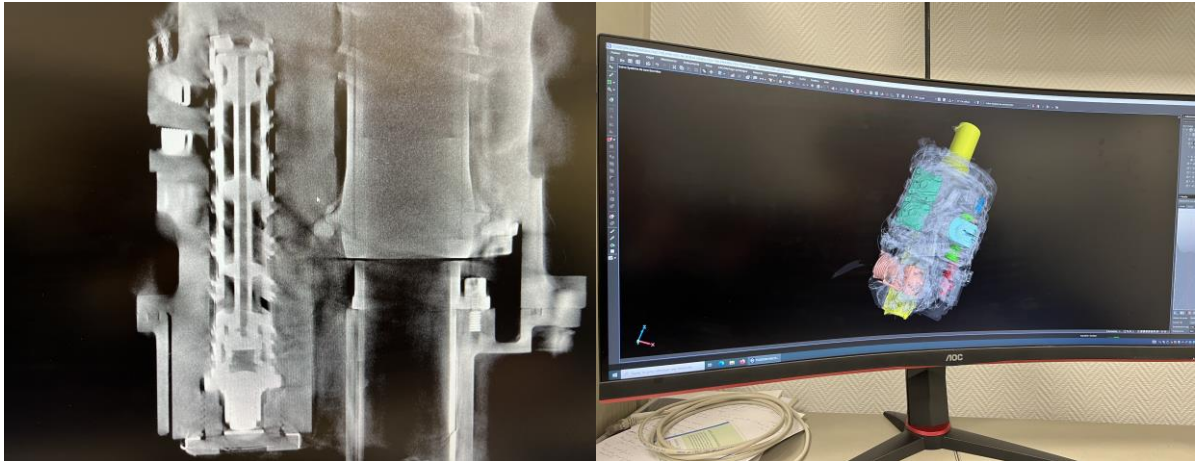
Figure 24 PVM as seen on X-ray during examination

The PVM was examined at BEA's laboratory using Computed Tomography scan and X-ray examination. Upon examination the spool of the protection valve within the PVM appeared to be mobile due to lack of hydraulic in the system. When the PVM was turned upside down, the spool followed the direction of gravity forces. Therefore, the spool position at the time of the event could not be determined rendering the information inconclusive to determine the propeller pitch command at impact.

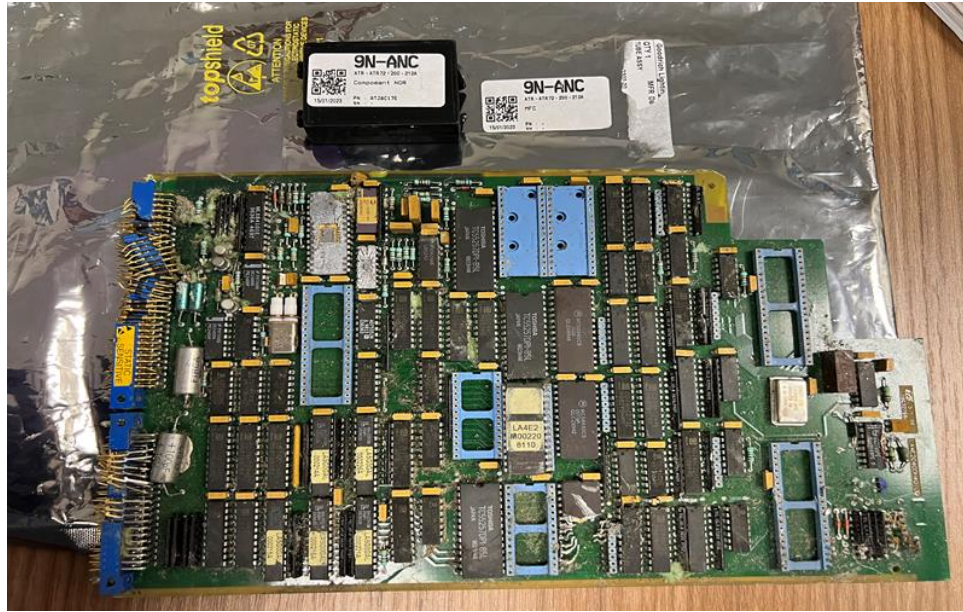
Fig. 25 Inner electric circuit and the memory chip

The Super Advanced BITE of the read and decoded MFC 2B non-volatile memory from the retrieved CPU card reveals no automatic feathering command activation by the MFC 2B for the accident flight. Both modules of each MFC were interfaced with one Auto Feathering Unit so with one engine, it can be concluded that no automatic feathering activation was commanded by the MFC on the right engine for the accident flight on January 15th 2023.

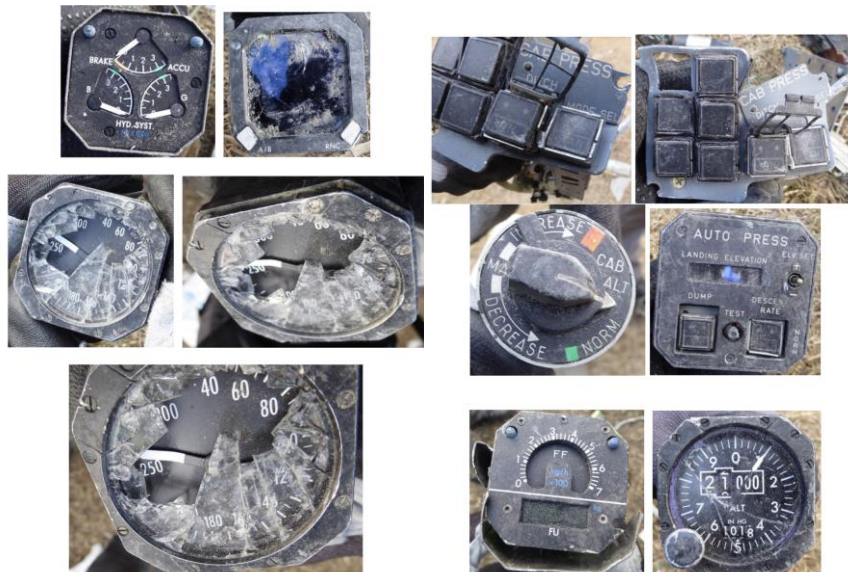
Figure 30 Instruments recovered from Site C

Fuel Flow Indicator: The needle was missing; no indication observed.

Flap Position Indicator: The needle was missing. The blue “EXT” indication was visible.

Hydraulic Triple Pressure Indicator: All three needles were present and were free to move. No needle marks observed on the face.

Interstage Turbine Temperature (ITT) Indicator: The needle was missing and no indication on the face.

Airspeed Indicator: The needle was free to move above 255 knots. Marks consistent with needle impact traces were observed pointing towards 260 knots.

RH Propeller Torque Indicator: The two needles were hard to move, but no evidence of needle trace was observed.

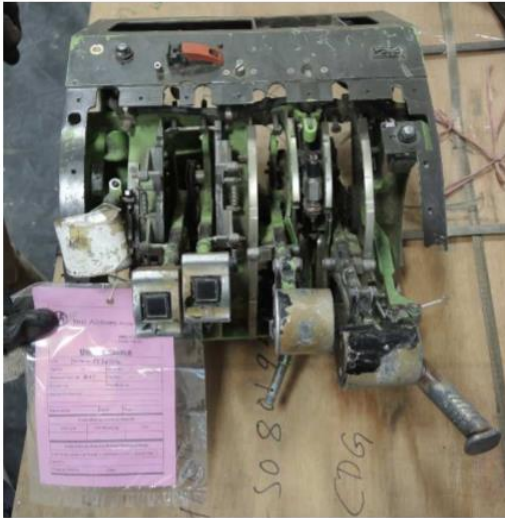
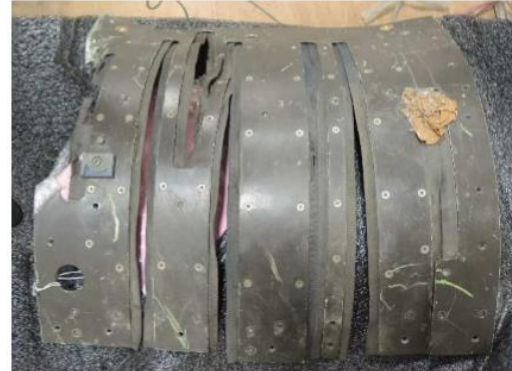
Figure 26 Control Pedestal of 9N-ANC

The witness marks from the pedestal indicates that the left condition lever was in the feathered position. Although the right hand condition lever did not have witness marks it is probable that the lever was also in the feathered position based on the FDR data and MFC examination corroboration.

- The flap lever was locked in the 30° position, with damage to the lever consistent with the application of a high force from the rear during the accident. As a result, the lever was clearly in the 30° position at impact.
- Traces and impact on the Condition Lever 1 rail are consistent with a FEATHER position at impact (no other impact on other position on the rail of Condition lever 1);
- No trace on the Condition Lever 2;
- Traces and damage on Power levers 1 and 2 are consistent with a position forward (zone corresponding to high power).
- The Gust Lock lever was moved rearward upon impact during the accident sequence and deformed. The lever was therefore forward before impact (normal position in flight).

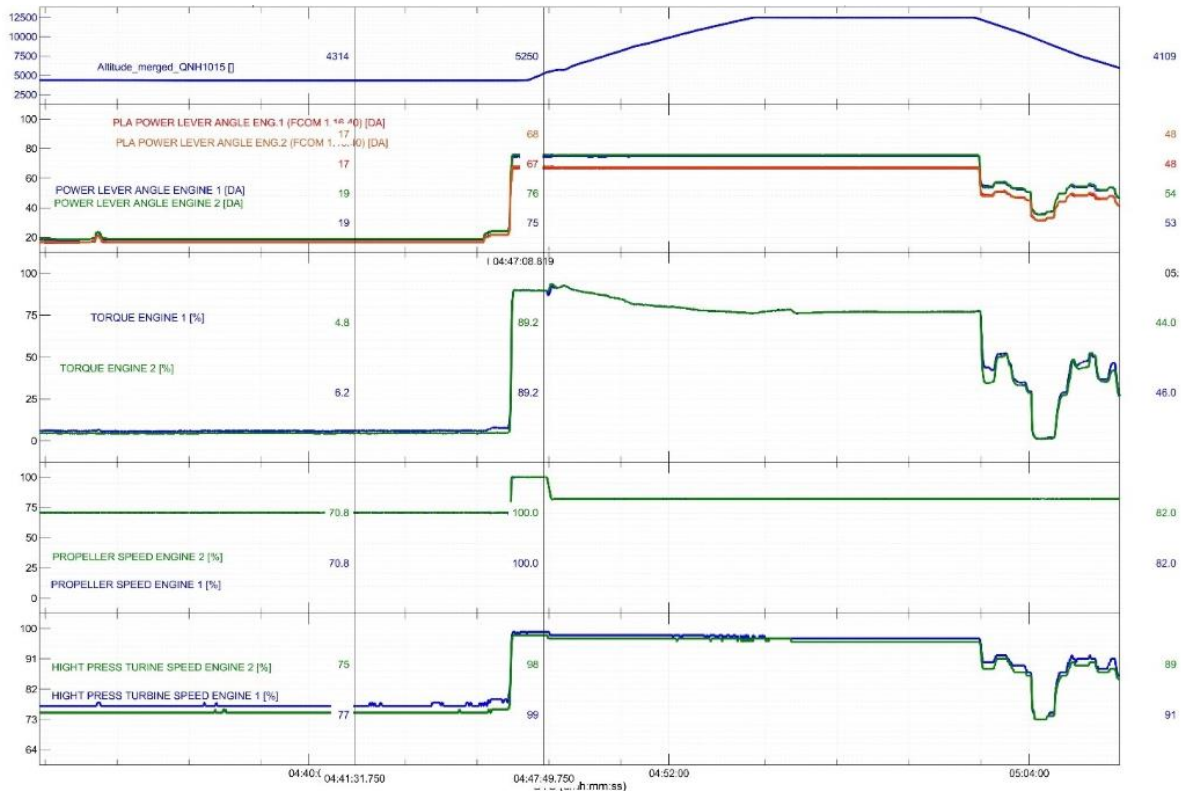
flap 30 was called (yet not acknowledged by the other crew) on the accident flight, the flaps were not deployed; rather both propellers went to feather resulting in loss of torque in both engines. However, when the flaps 30 were finally deployed, there were no recorded callout from either cockpit crew.

Figure 35 Engine and propeller parameters as per FDR
