# Aviation and Railway Accident Investigation Board

## Aviation Accident Preliminary Report

HL8088 (B737-800) belly landing, runway overrun and crash to embankment

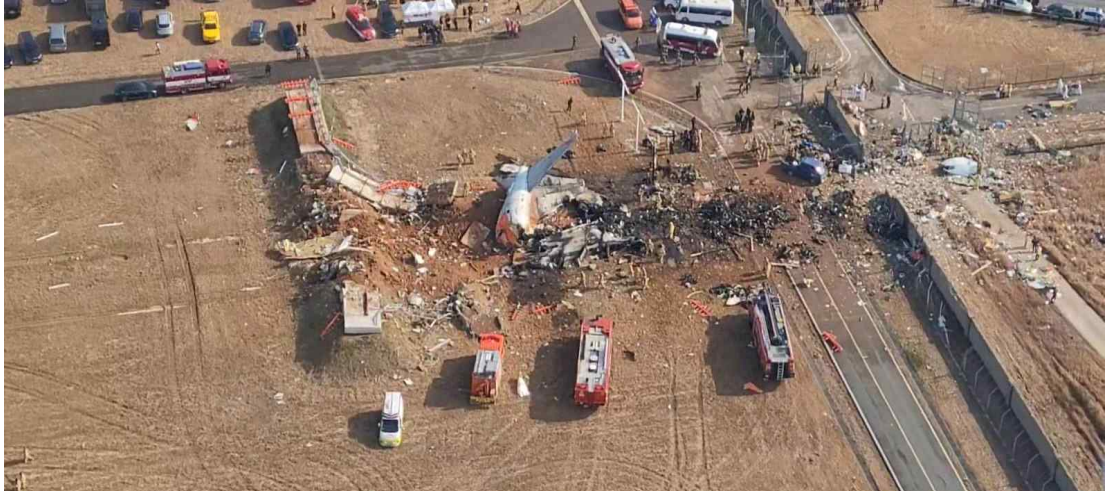
Accident scene

After the crash into the embankment, fire and a partial explosion occurred. Both engines were buried in the embankment's soil mound, and the fore fuselage scattered up to 30-200 meters from the embankment. The empennage flipped and fell beyond the embankment, partly burning.

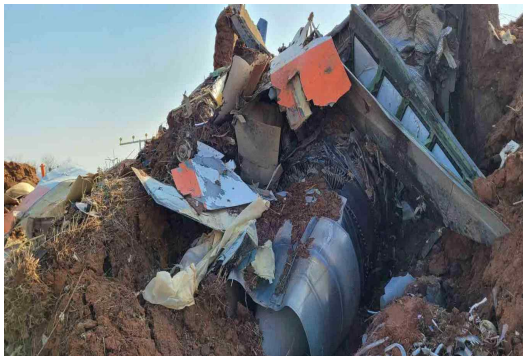
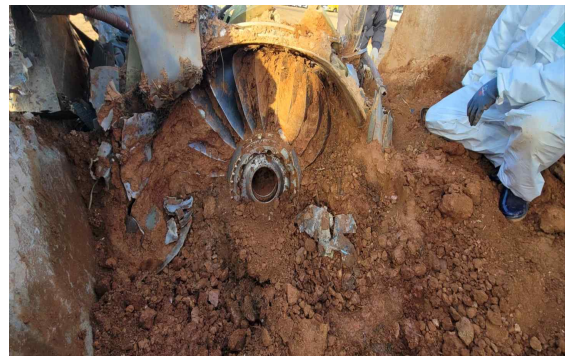
Engines

The pilots identified a group of birds while approaching runway 01, and a security camera filmed HL8088 coming close to a group of birds during a go-around. Both engines were examined, and feathers and bird blood stains were found on each. The samples were sent to specialized organizations for DNA analysis, and a domestic organization identified them as belonging to Baikal Teals.

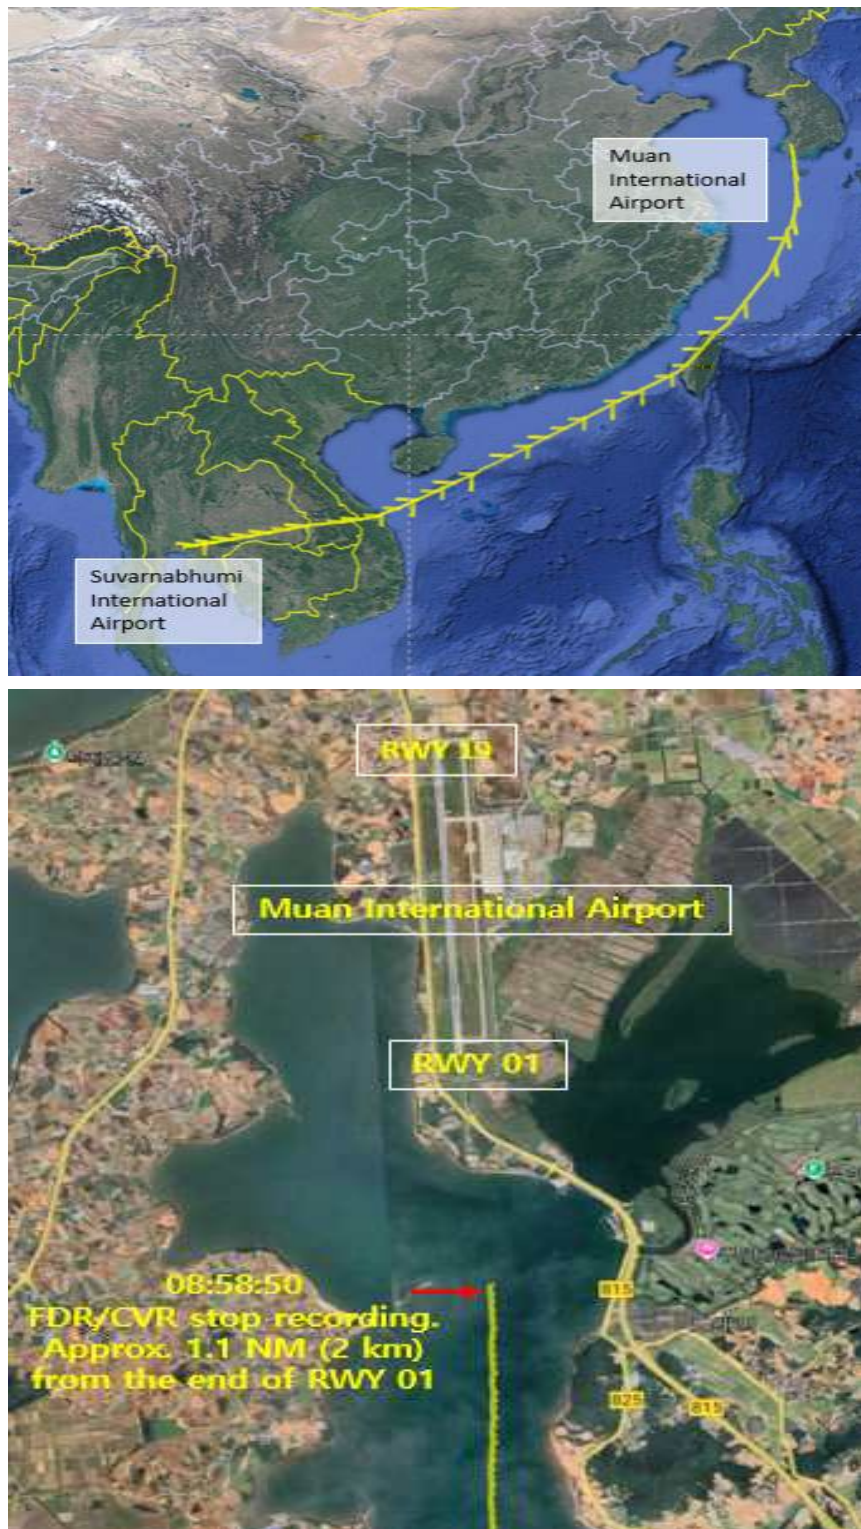
Figure 2. Flight path while the CVR/FDR are in operation

Flight data recorder (FDR) and cockpit voice recorder (CVR) were installed in HL8088. However, both recordings stopped at 08:58:50 on December 29, 2024. The airplane impacted with the embankment at 09:02:57, meaning the last 00:04:07 recordings were missing. The airplane

speed and pressure altitude when the recorders stopped were 161 kts and 498 ft, respectively. Figure 2 shows the flight path of HL8088 from its takeoff to where its flight recording stopped.
