Islamic Republic Of Iran
Civil Aviation Organization
Aircraft Accident Investigation Board

Final Report

Aircraft Model: Bombardier CL604 Challenger

Registration: TC-TRB

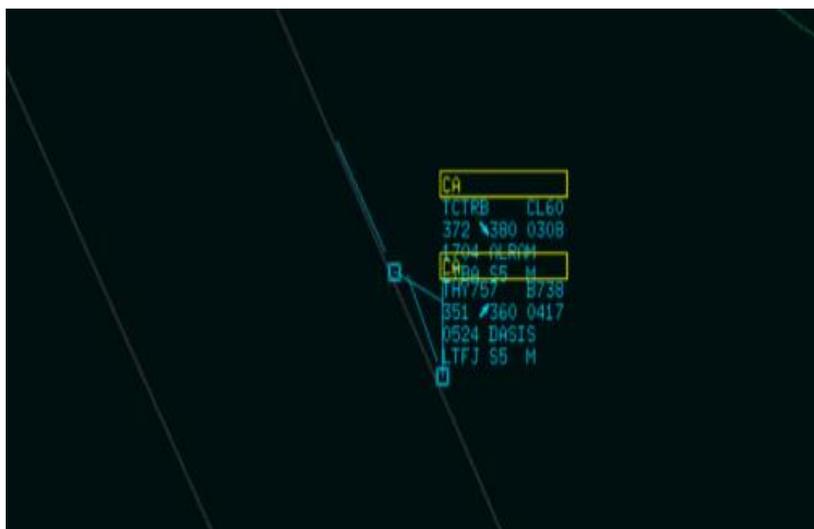
At 14:34:37, while reaching FL 379, the pilot declared descending to FL 370 due to malfunction and started its descend to the wrong flight level without waiting for ATC approval. It was just after descending that the controller approved FL 370. Based on the information displayed on radar screen, the aircraft's speed was reduced from 390 kt at FL 360 to 316 kt at FL 379.

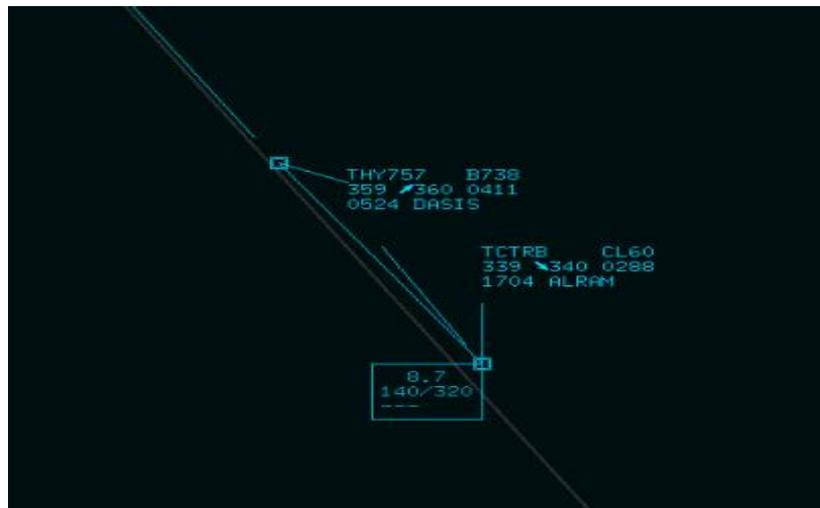
At 14:35:36, while aircraft's speed displayed on the radar further reduced to 288 kt, the pilot declared that they are continuing descend to FL340.

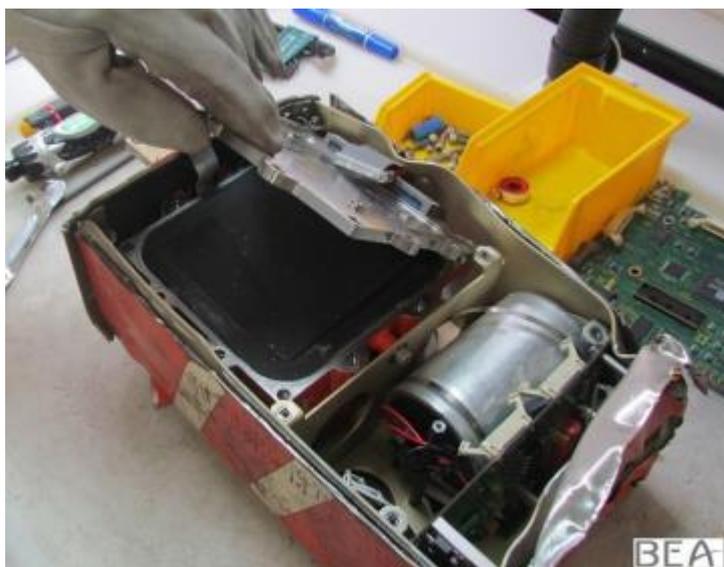
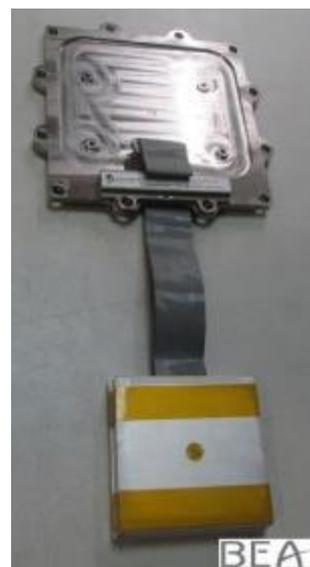
The FCSSU was opened and the metallic casing was extracted from the recorder.

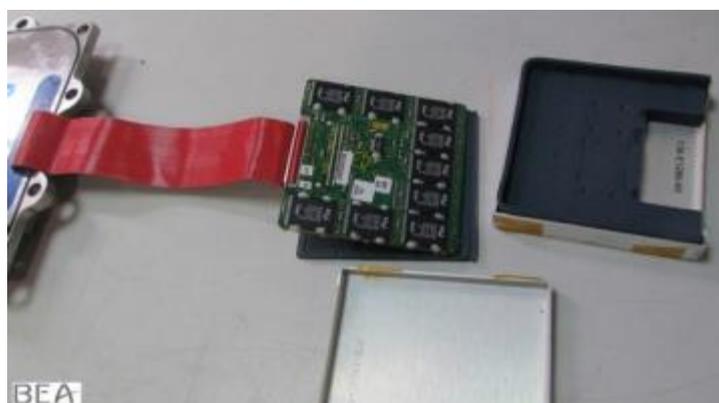
The memory board was extracted from its metallic casing.

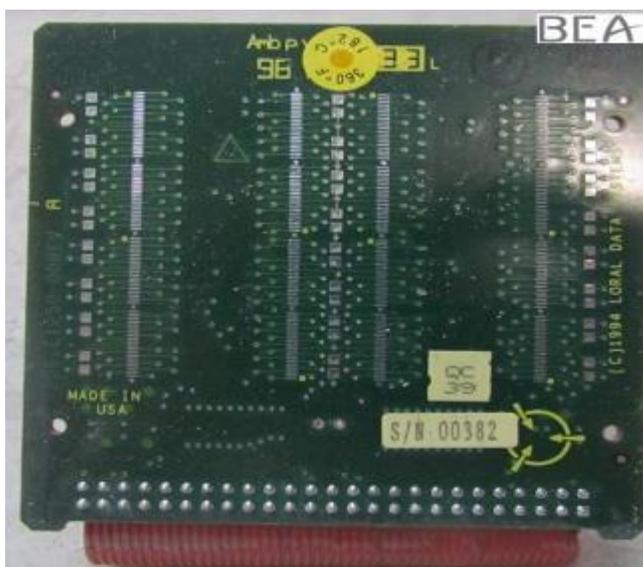
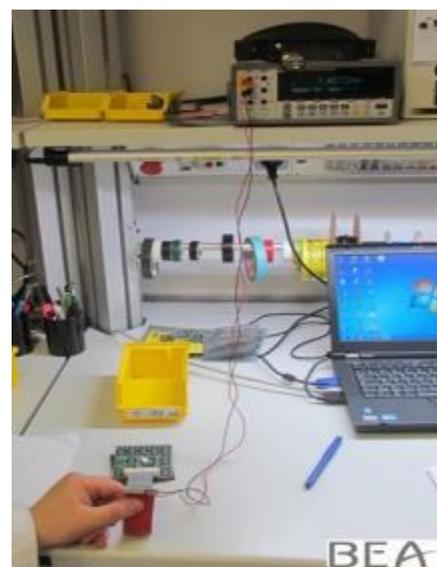
The FDR FCSSU was visually checked. The connector of the memory board was damaged.

The metallic casing was removed, the memory board was visually inspected, a new fifty-pin connector was installed on the ribbon cable and electrical checks were performed on the new connector.

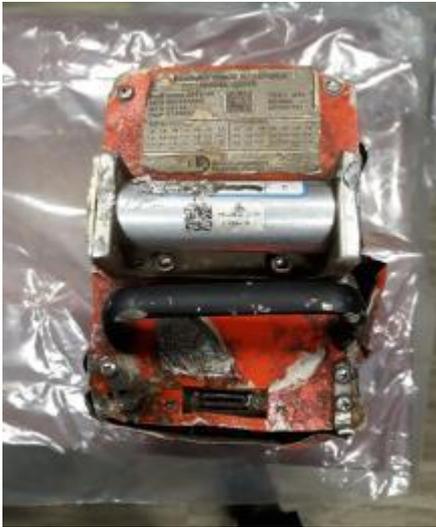
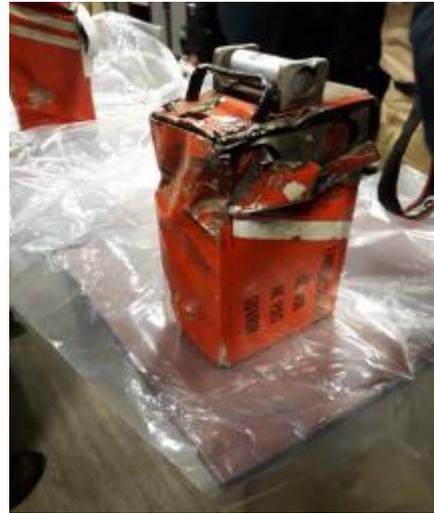
The CVR opening operations took place in BEA facilities. A visual Assessment of the CVR was performed. The recorder was damaged. The ULB was still attached to the chassis.

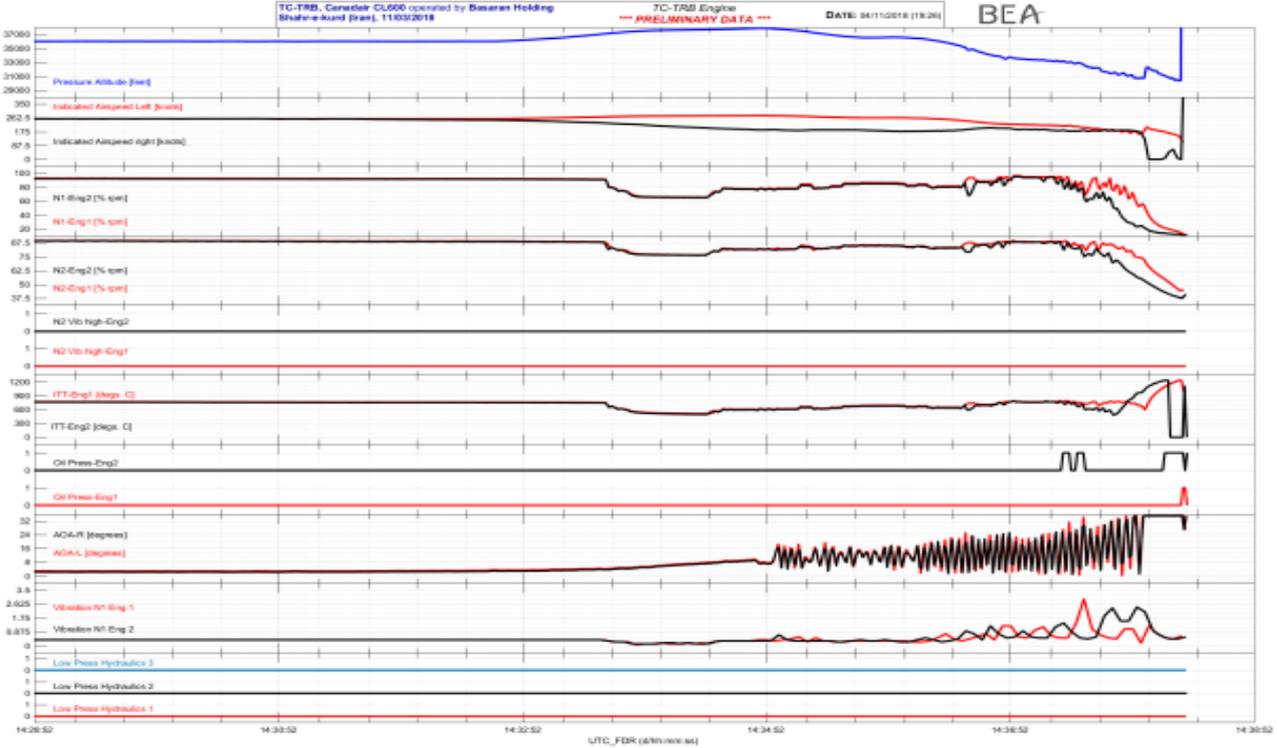
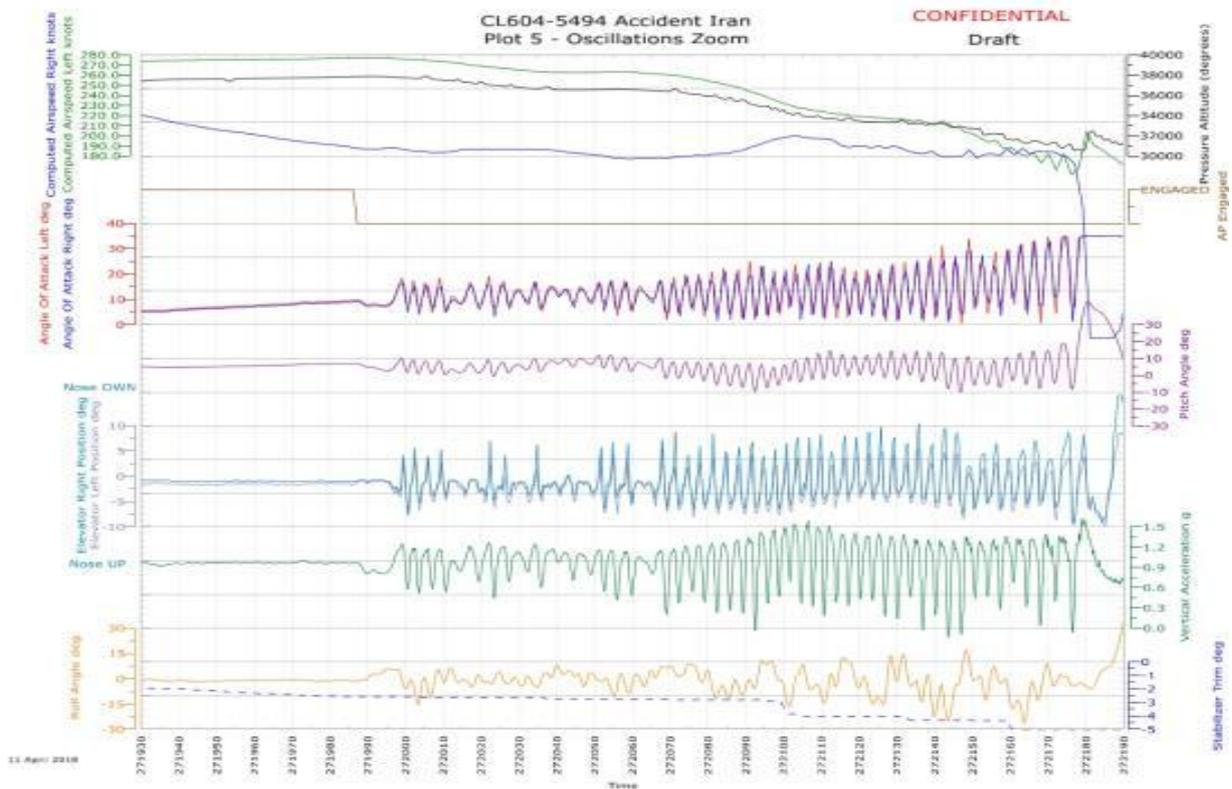
While aircraft was descending through FL370, the engine power and actual aircraft speed had reduced to stall speed but overspeed clacker was activated due to failure on indication system. The pilot never followed stall recovery procedures because she had a mind of overspeed by clacker warning [MMO over speed] on the cockpit. The stick pusher acted to pitch down aircraft to prevent stall condition but the captain's reaction on the control column just was in the opposite direction. During this time, the aircraft entered a series of pitch and roll oscillations.

The autopilot was disengaged by the crew before stall warning, which ended in oscillation of control surfaces based on FDR information. Engine power began to decrease on both sides until both engines flamed out in stall condition and FDR data recording was lost at this point. Data from the FDR shows that the aircraft experienced close to about 50 rapid pitch cycles following the activation of the stall protection systems, the result of the crew actively fighting against the pusher system.
