This document is an English translation of the Final Report on the fatal accident involving the Boeing 747-412F aircraft registered TC-MCL that occurred on January 16th, 2017 at Manas International Airport, Bishkek, Kyrgyz Republic.

**INTERSTATE AVIATION COMMITTEE
AIR ACCIDENT INVESTIGATION COMMISSION**

**FINAL REPORT
ON RESULTS OF THE AIR ACCIDENT INVESTIGATION**

Type of occurrence	Fatal accident
Type of aircraft	Boeing 747-412F
Registration mark	TC-MCL
Owner	LCI Freighters One Limited (Ireland)
Operator	ACT Airlines
Aviation Authority	Directorate General of Civil Aviation of Turkey (Turkish DGCA)
Place of occurrence	Near Manas International Airport, Bishkek, Kyrgyz Republic, coordinates: N 43°03.248' E 074°2.271'
Date and time	16.01.2017, 07:17 local time (01:17 UTC), night time

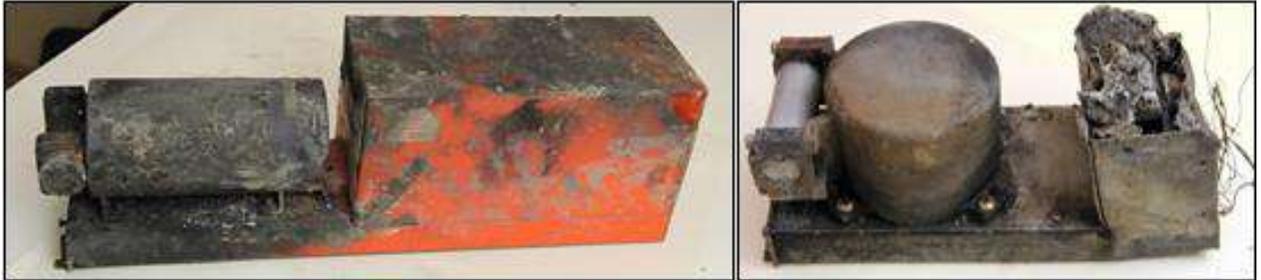
Figure 12. Inboard flight data monitoring and recording equipment

The Digital Flight Data recorder (FDR) and cockpit voice recorder (CVR) have been found at the accident site near the aircraft tail empennage fragment (Figure 12).

- the DFDR casing and the protected memory unit show traces of thermal impact (Figure 12);
- the protected memory unit casing has no mechanical damage nor deformation;
- the front connector has been destroyed due to the thermal impact;
- the aft connector has some insignificant damage;
- the plate with the serial and part numbers has been destroyed due to the thermal impact.

- the CVR casing and the protected memory unit show traces of thermal impact (Figure 12);

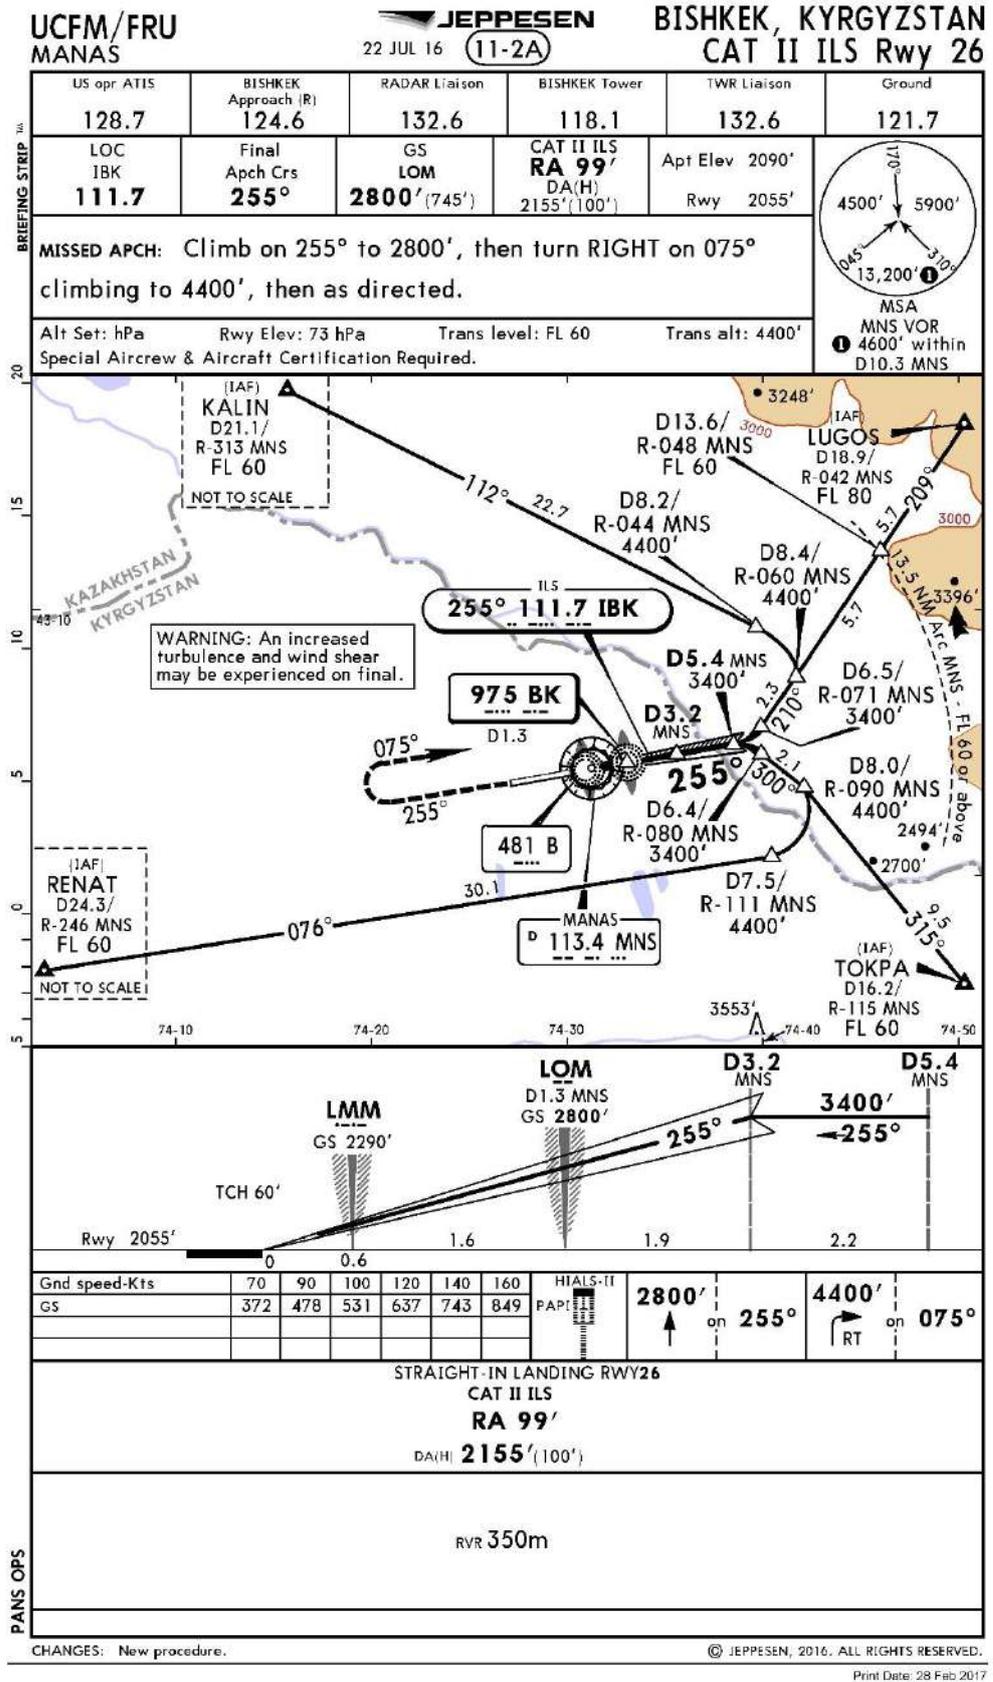
Figure 23. RWY 26 approach chart (Jeppesen)

The flight past TOKPA was performed at 01:11:18, the aircraft reached 9200 ft in descent with the IAS of approximately 270 kt. According to the chart, the flight past TOKPA must be conducted at 6000 ft (FL 060) or above. Thus, the chart requirements were not formally violated, but the aircraft was too high for continuing the approach in accordance with the chart without additional maneuvering for decreasing the altitude (Figure 23 and Figure 24).

The flight past the D 8.0/R-090 MNS 4400 guidepoint was performed at 01:13:28 at 6500 ft with the IAS of 220 kt (Figure 37). Thus, the aircraft was 2100 ft higher than the approach chart requires. (Figure 23 and Figure 24).

According to the Boeing 747 FCOM and ACT Airlines SOP, at the point of Final Approach Fix (FAF), the crew must check the flight altitude. The onboard recorder contains no data confirming that the crew performed this procedure. For Manas aerodrome (Bishkek), this point corresponds to the Final Approach Point (FAP D 6.0 ¹⁴3400' and is provided in the RWY 26 approach chart of AIP of the Kyrgyz Republic (Figure 24)). In Jeppesen Route Manual, which was used by the crew (Figure 23), the FAP/FAF is not shown.

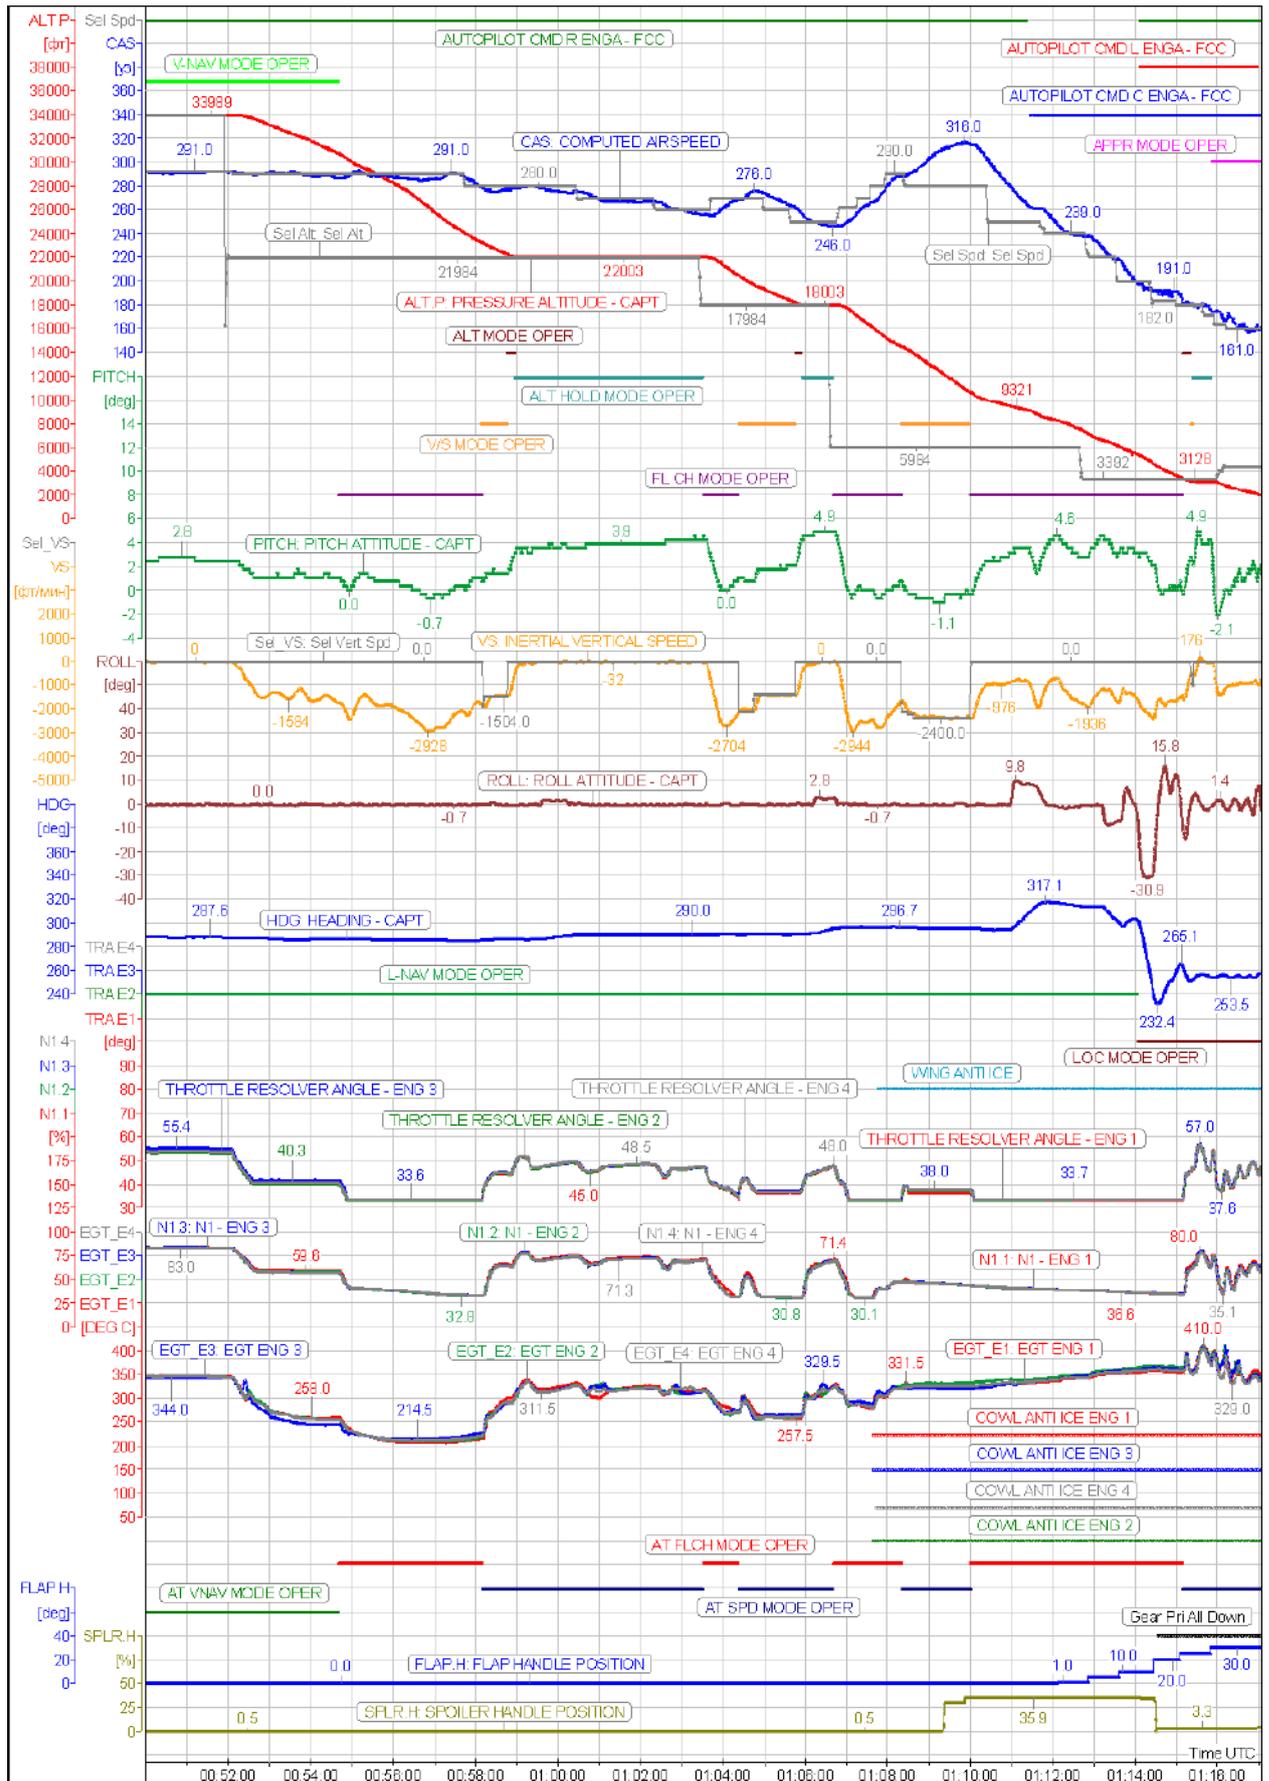
Figure 35. Aircraft flight parameters (descent and approach)

At the start of descent, the AP "VERTICAL NAVIGATION OPER" mode was engaged in the longitudinal control channel and the "LATERAL NAVIGATION OPER" mode was engaged in the lateral control channel. The selected altitude⁹ was set to 22 000 ft. The average rate of descent was approximately 1450 ft/min, the IAS was 290 kt (Figure 35).

At 01:03:31, the "FLIGHT LEVEL CHANGE OPER" mode was engaged in the longitudinal channel, and the aircraft started the descent with the vertical speed of up to 2700 ft/min. The "LATERAL NAVIGATION OPER" mode was still engaged in the lateral channel. The selected altitude was set to 18 000 ft. 50 seconds after the start of descent, the "V/S MODE OPER" mode was engaged in the longitudinal channel. The selected speed of descent was 2100...1400 ft/min and was the same as the true vertical speed of descent (Figure 35).

The distance between the RAXAT and TOKPA reporting points is 27 nm. According to the approach chart and the controller's instruction, at this distance it was necessary to descend to 12 000 ft. Thus, the given distance was not enough for the standard descent procedure, required by ACT Airlines SOP (in this case the aircraft would descend approximately 9000 ft lower and would reach TOKPA at approximately 9000 ft instead of [the required] 6000 ft). Despite this, the initial descent was conducted without the use of the speedbrakes and with the increase of the IAS. After the initial descent, the MCP IAS was reset from 262 kt first to 270 kt and then to 280 kt (Figure 35).

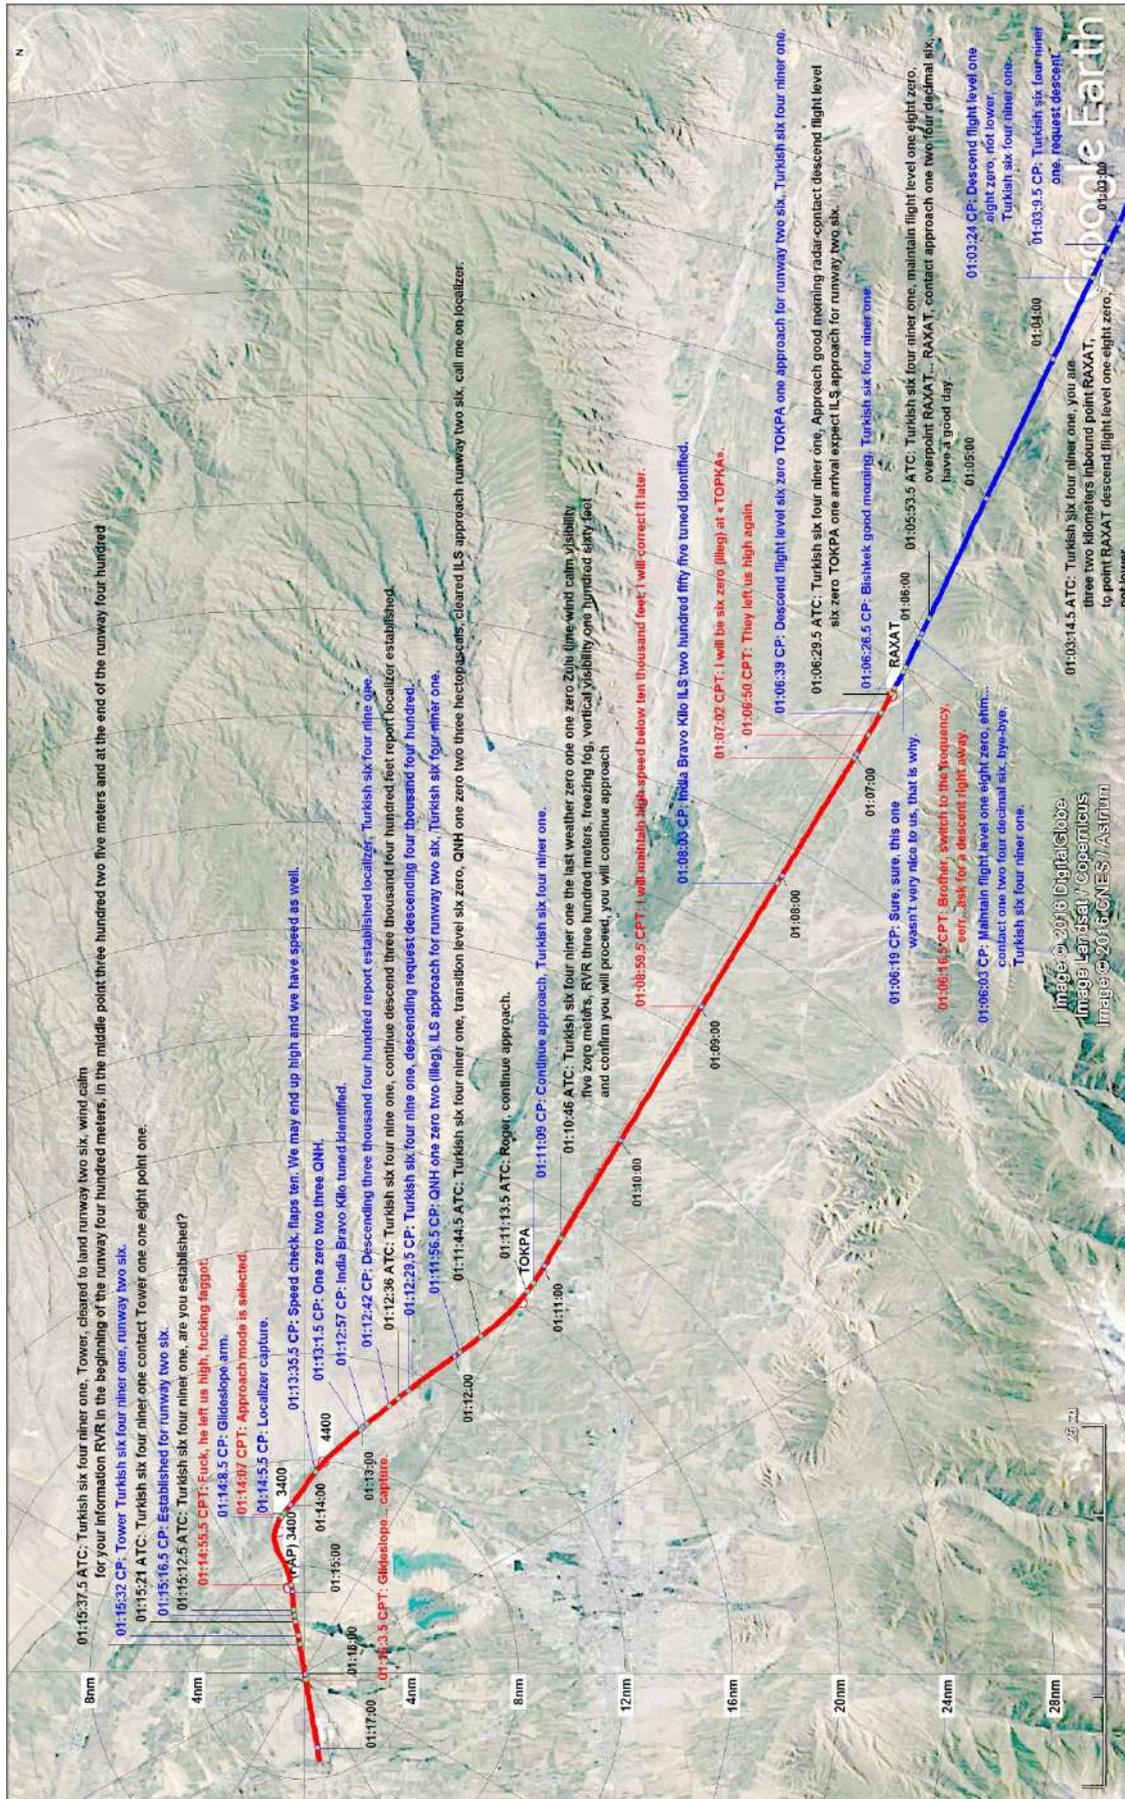
Figure 36. Aircraft flight trajectory during the approach and landing at Manas aerodrome (Bishkek)

At 01:06:30, when flying over RAXAT, the aircraft was positioned at FL 180. The descent from FL 180 was started at 01:06:40. At the beginning of the descent, the crew engaged the autopilot in the "FLIGHT LEVEL CHANGE OPER" mode in the longitudinal channel and the "LATERAL NAVIGATION OPER" mode in the lateral channel. The selected altitude was set to 6000 ft, the selected IAS on the MCP was set to 262 kt, the aircraft engines were operating in the mode close to the flight idle. At the beginning of the descent, the vertical speed was 2900...2700 ft/min. Judging by the phrase "*I will be six zero (illeg) at "TOPKA"*¹¹", the PIC was expecting to reach FL 60 by the time the aircraft reached the reporting point (Figure 36).

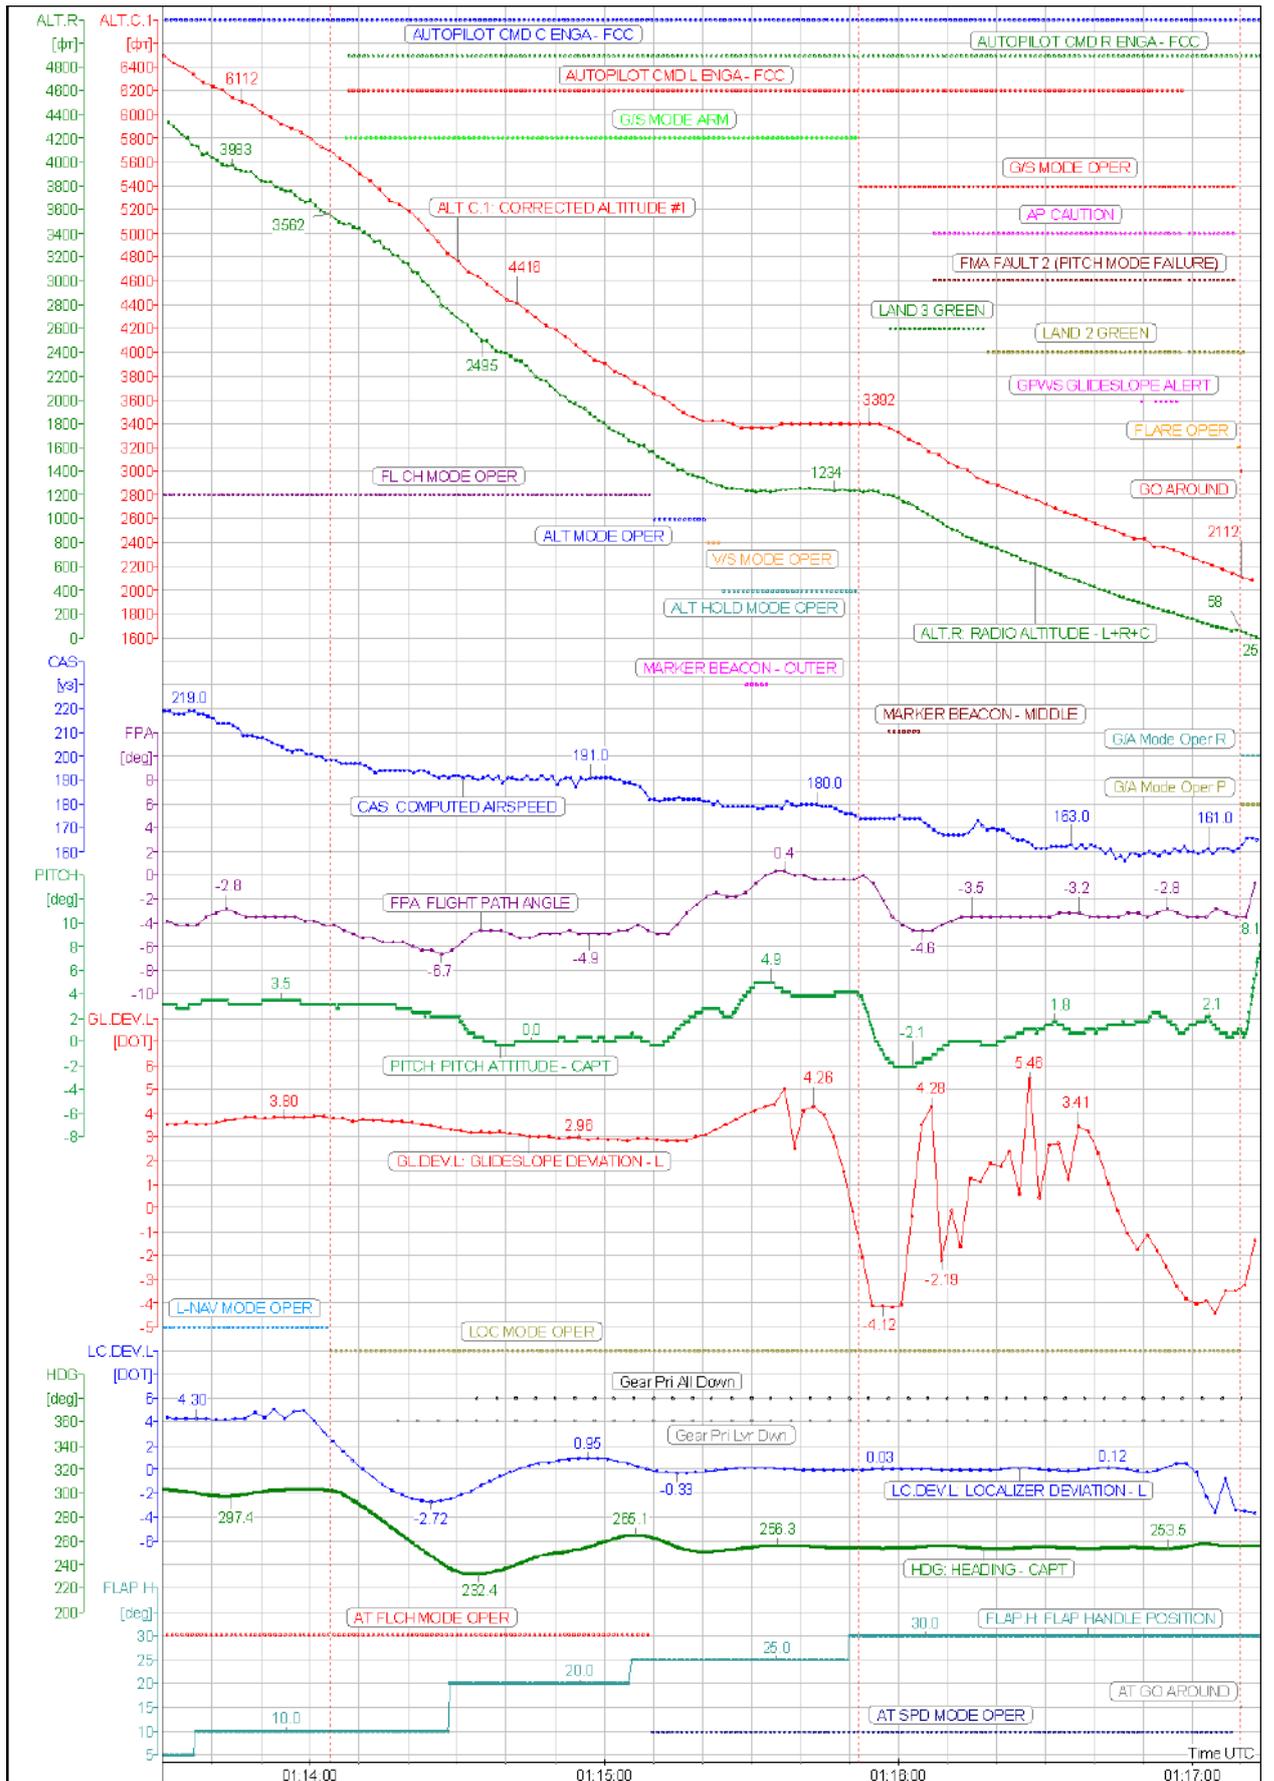
Figure 38. Aircraft flight parameters (approach)

At 01:13:55, the "LOC MODE ARM" mode was engaged, and at 01:14:05 the localizer capture and the start of the automatic positioning for approach were recorded. At that time, the aircraft was positioned at the distance of approximately 6.1 nm in the descent mode, the flight altitude was approximately 5700 ft and the IAS was 200 kt (Figure 38).

At 01:15:25, the aircraft performed the descent to the altitude of 3400 ft, the autopilot "ALT HOLD OPER" mode was engaged in the longitudinal channel. Thus, the altitude of glideslope capture was reached only at the distance of ≈ 1.7 nm (while the FAP is located at the distance of 3.2 nm). The further flight was performed at the constant altitude almost along the RWY 26 centerline. The aircraft was positioned considerably higher than the glidepath; according to the recorded information, the value of the "deviation from the equisignal glidepath zone" was +4...+5 dots, (the digit "+" corresponds to the position of the aircraft above the glidepath). The "G/S MODE ARM" was engaged; however, no glideslope capture occurred (Figure 38).

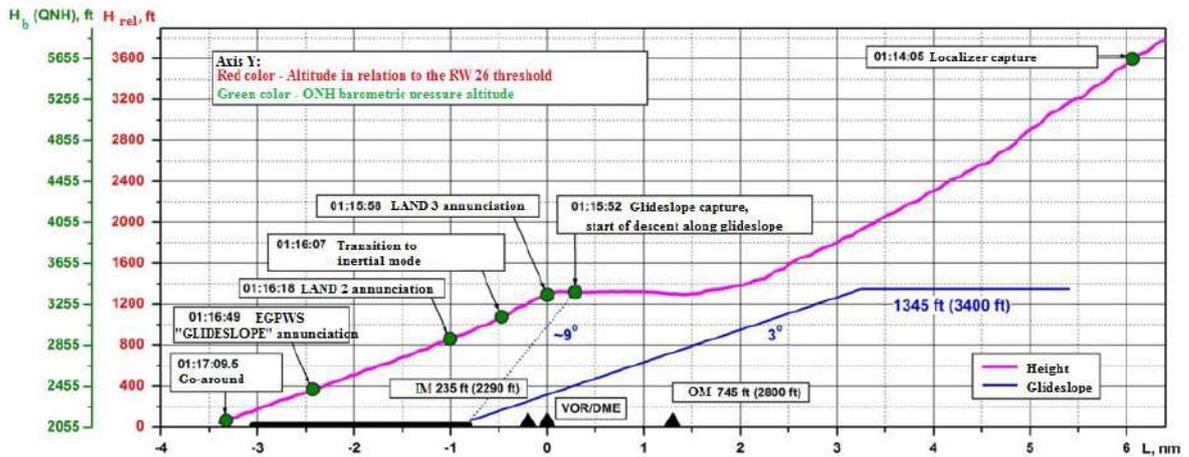
Figure 39. Aircraft flight trajectory during approach and landing at Manas aerodrome (Bishkek)

The capture of the signal from the glideslope beacon occurred at 01:15:52, at that time the aircraft was positioned at the distance of approximately 1.15 nm form the RWY 26 threshold, the angle of the caught glideslope beacon signal was $\approx 9^\circ$, the flight altitude was 3400 ft (Figure 39). The nominal glidepath angle, required by the approach chart is 3° . Thus, in the accident flight, the capture of the "true" glideslope signal could have been performed only "from above", that is the aircraft must have been in the descent mode. In fact, the glideslope signal capture was performed in the aircraft in cruise flight; however, the crew did not pay proper attention to this fact.

The analysis of the disposed information may lead to a conclusion that the onboard system of the aircraft captured the "false" glideslope signal with the angle of $\approx 9^\circ$. Besides, the aircraft design company confirmed that the glideslope signal capture was conducted in a "standard" way, as all the conditions, under which the on board equipment determines that the aircraft is approaching the equisignal zone, were fulfilled. The feature of monitoring the aircraft position in relation to the RWY is not provided in the glideslope capture algorithm by design.
