*Final Report on the accident of ATR72/212A version 500 (Registration:9N-ANC) that occurred on
January 15, 2023 near Pokhara International Airport*

GOVERNMENT OF NEPAL
AIRCRAFT ACCIDENT INVESTIGATION COMMISSION

FINAL REPORT

**9N-ANC (ATR 72-212A, MSN : 754) AIRCRAFT OPERATED BY YETI AIRLINES PVT.
LTD OCCURRED AT
POKHARA (AT THE BANK OF SETI RIVER - GHARIPATAN), KASKI DISTRICT, NEPAL ON
15 JANUARY 2023**

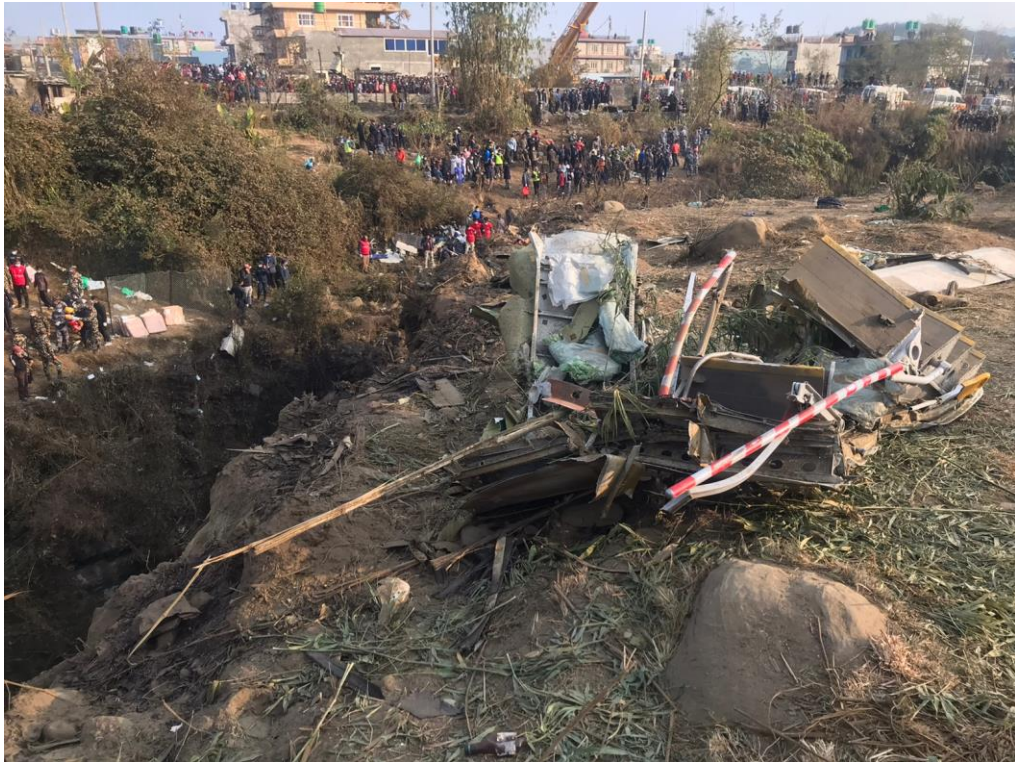
Figure 3 Location of the crash site

The aircraft was completely destroyed due to the impact and post impact fire. Most of the fuselage structure, engines and its components were consumed by the fire. The propeller blades were found damaged, detached from the engine at various locations near the point of first impact. The wreckage was located at a gorge on the bank of the Seti Gandaki River and around the bank.

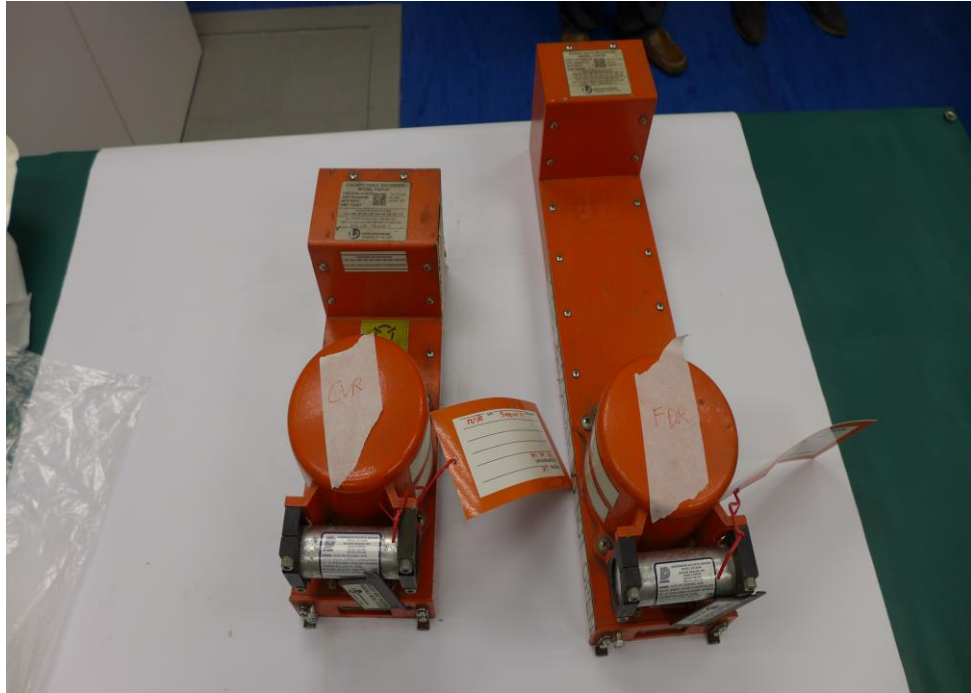
Figure 8 Status of recorders before read-out

The aircraft was fitted with L3 Communications model FA2100-4043-00 FDR, serial number 000592732, and L3 Communications model FA2100-1020-02 CVR, serial number 000494558.

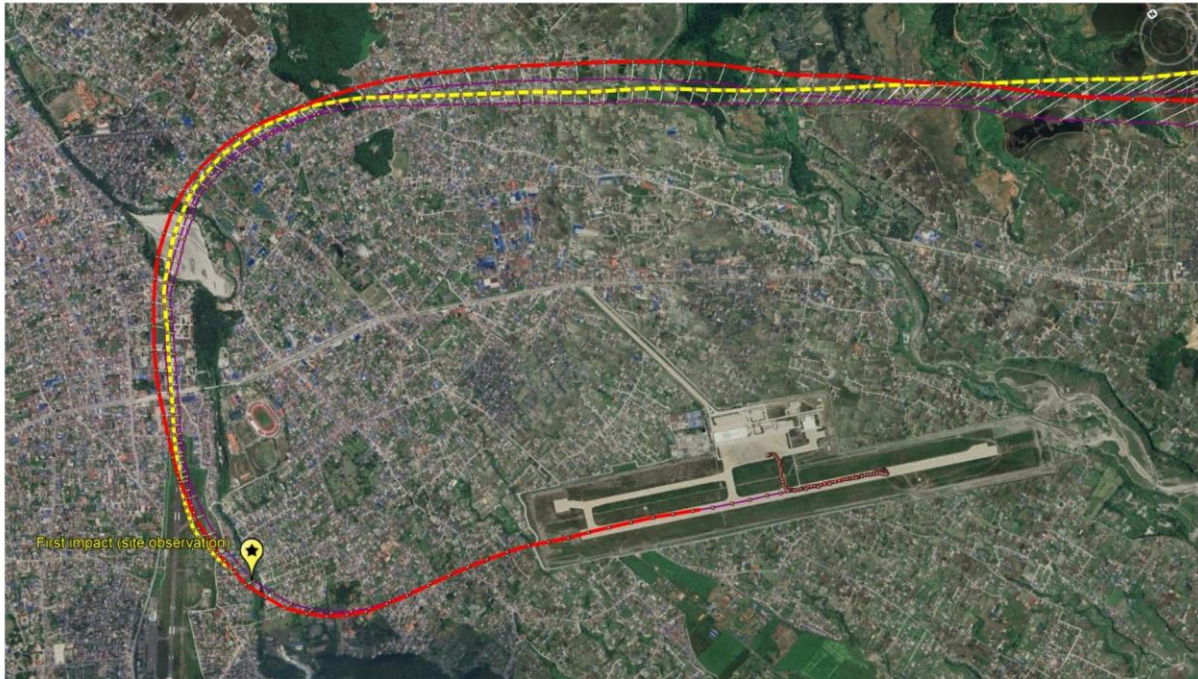
Figure 9 Flight Trajectory of the flight on 15th (Yellow) and 12th (Red) Jan 2023

From the retrieved FDR data, the investigation team was able to recover the flight path of the event flight and another flight on 12 Jan 23, where another set of crew landed on Runway 12 of VNPR.

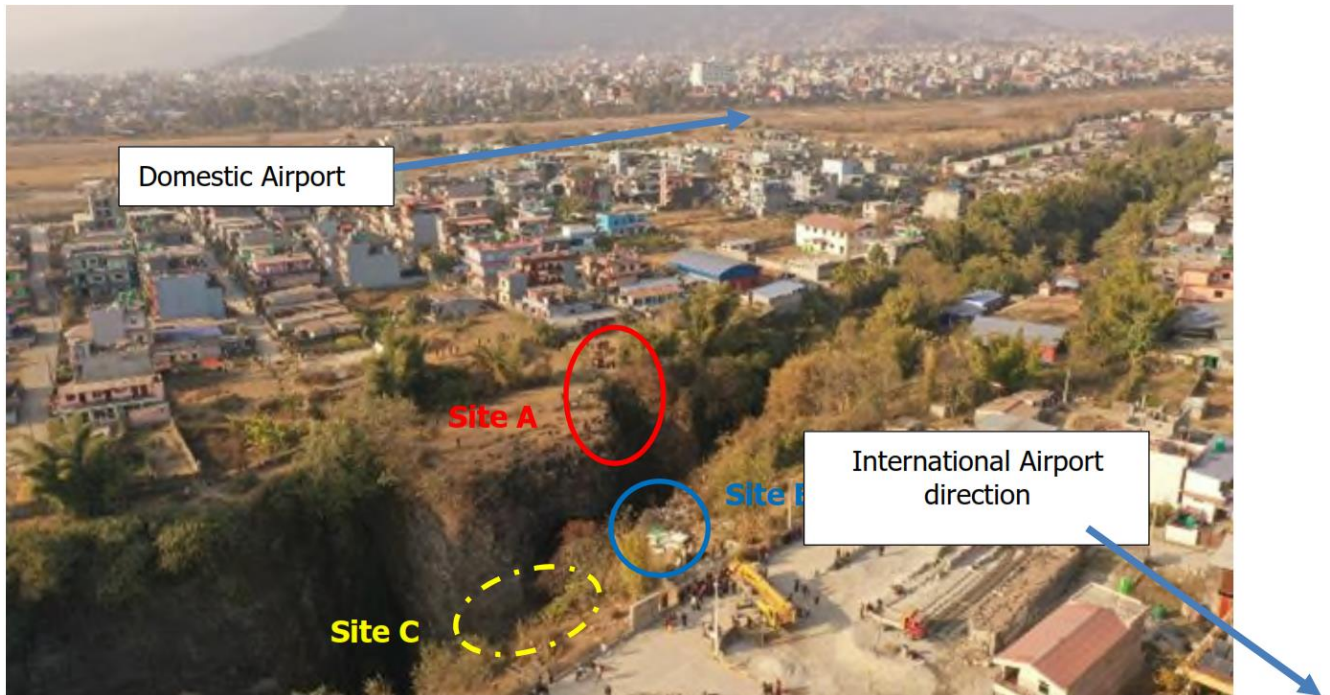
Figure 10 Aerial view of Sites A, B and C

The wreckage was primarily spread across three sites as depicted below as site A, site B and site C.

The aircraft initially impacted the ground with the left-wing tip box resulting in disintegration of LH outer wing box, LH aileron tip and PAX door at site A before it toppled over the gorge. The right wing and right engine section lodged into the adjacent wall at Site B whereas the cockpit, rear fuselage section, the overall tail section, the left engine and some of the rear fuselage dropped down the gorge to site C. Some major parts were transferred from the gorge to site B using a crane during Search and Rescue before the on-site investigation.

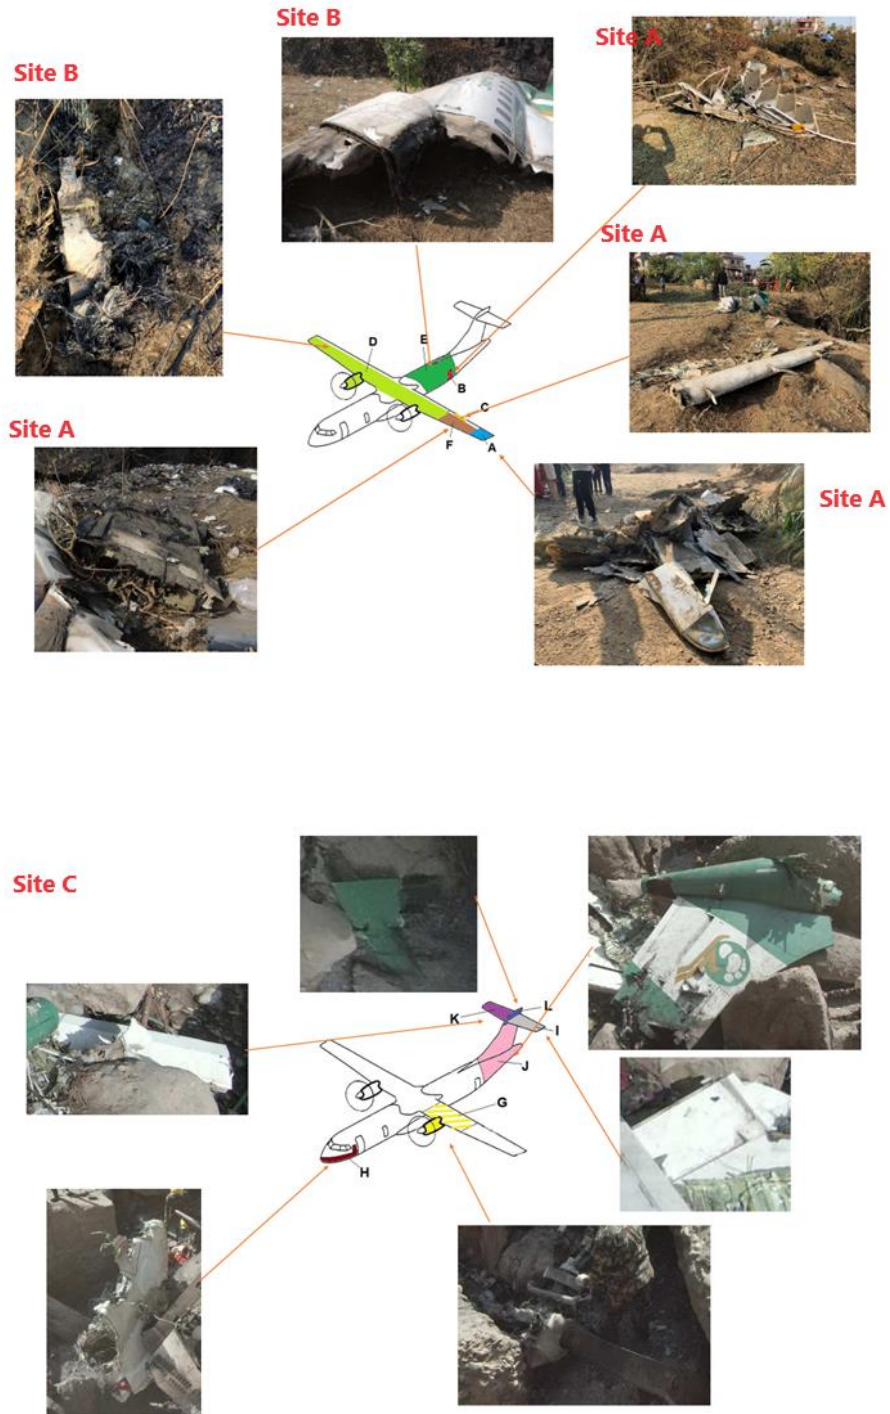
Figure 11 overview of wreckage distribution

The pictures below depict a global overview of the wreckage as identified on site visit

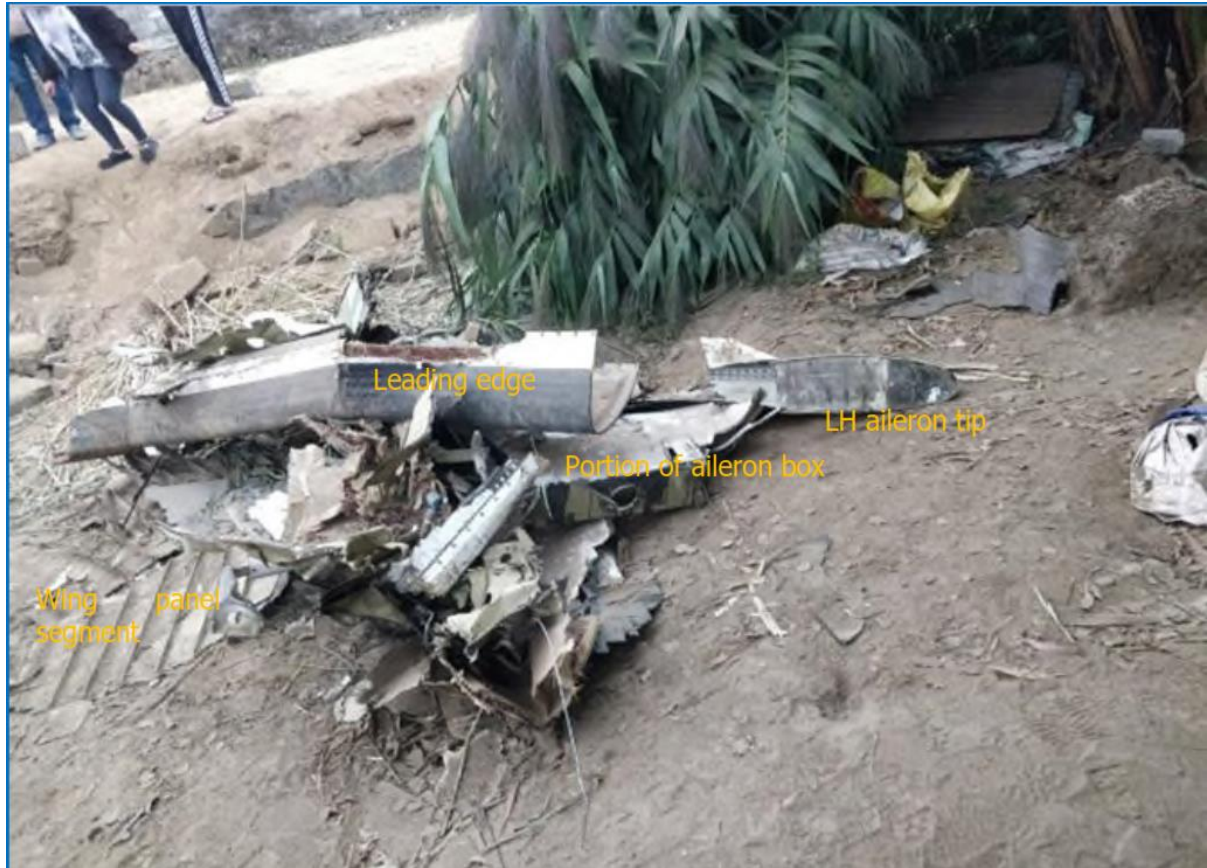
Figure 14 SITE A- Close up of the blue box on the picture above

Site A: identified aircraft impact points plus aircraft parts such as PAX door and LH outboard flap, miscellaneous belly fairing panels and cabin partition, LH outer wing box, panel segment, leading edge, LH aileron tip and portion of aileron box.

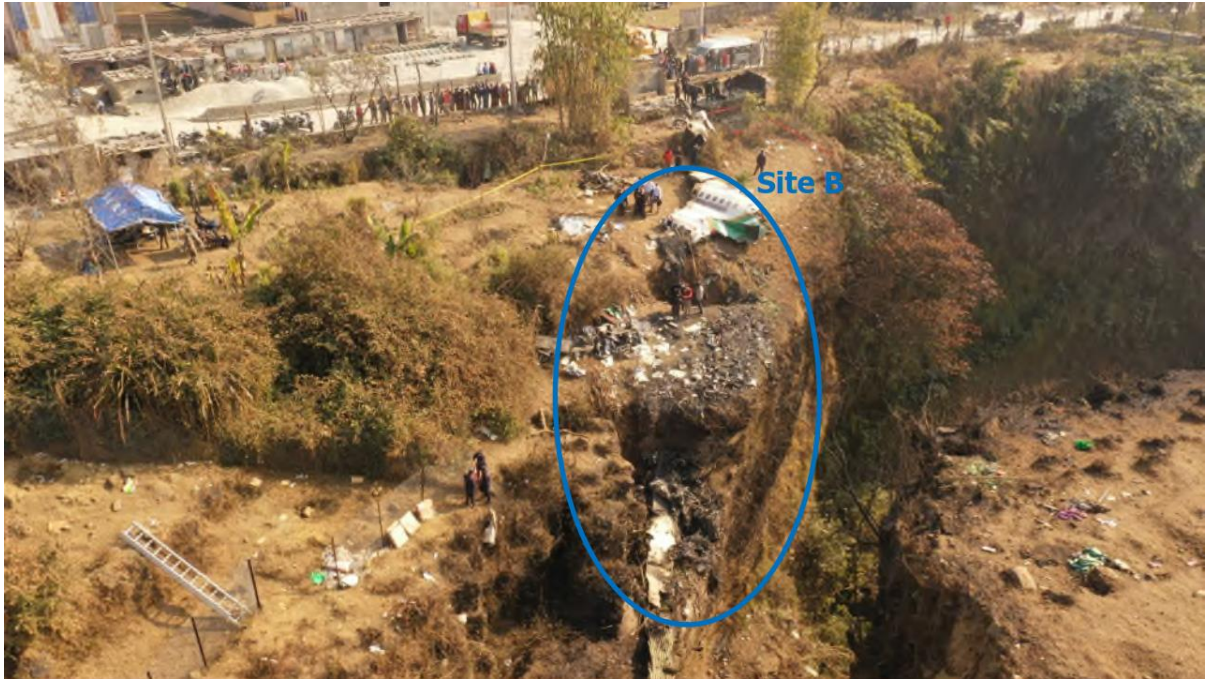
Figure 15 Aerial view of Site B

Site B – identified rear section, RH MLG area, portion of wing (RH side plus LH/center upper area) and RH outer wing box plus miscellaneous cabin/seats items, portion of wing/nacelle/engine (RH side plus LH/center upper area), plus fragment from LH MLG shock absorber.

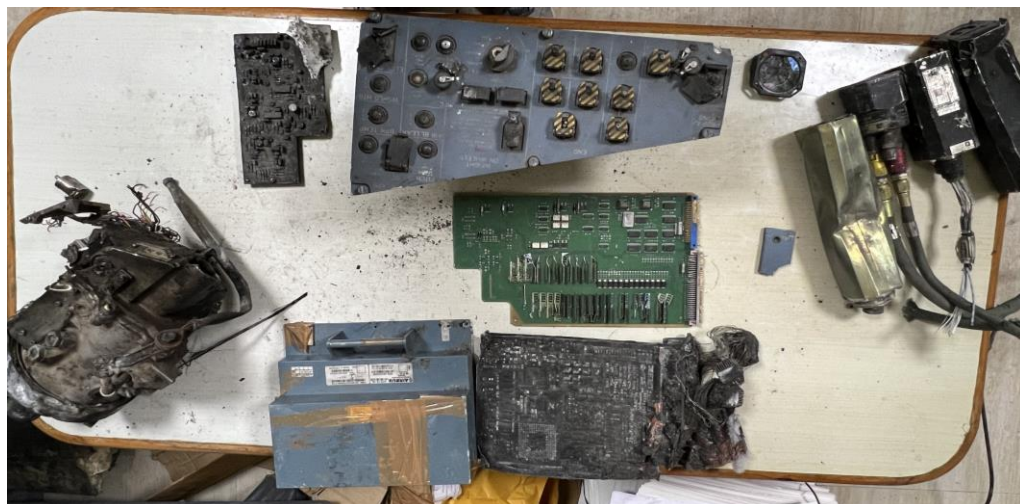
Figure 18 components

The Aircraft structure was completely destroyed and scattered throughout the sites A, B, C and also along the riverbed of the Seti river gorge.

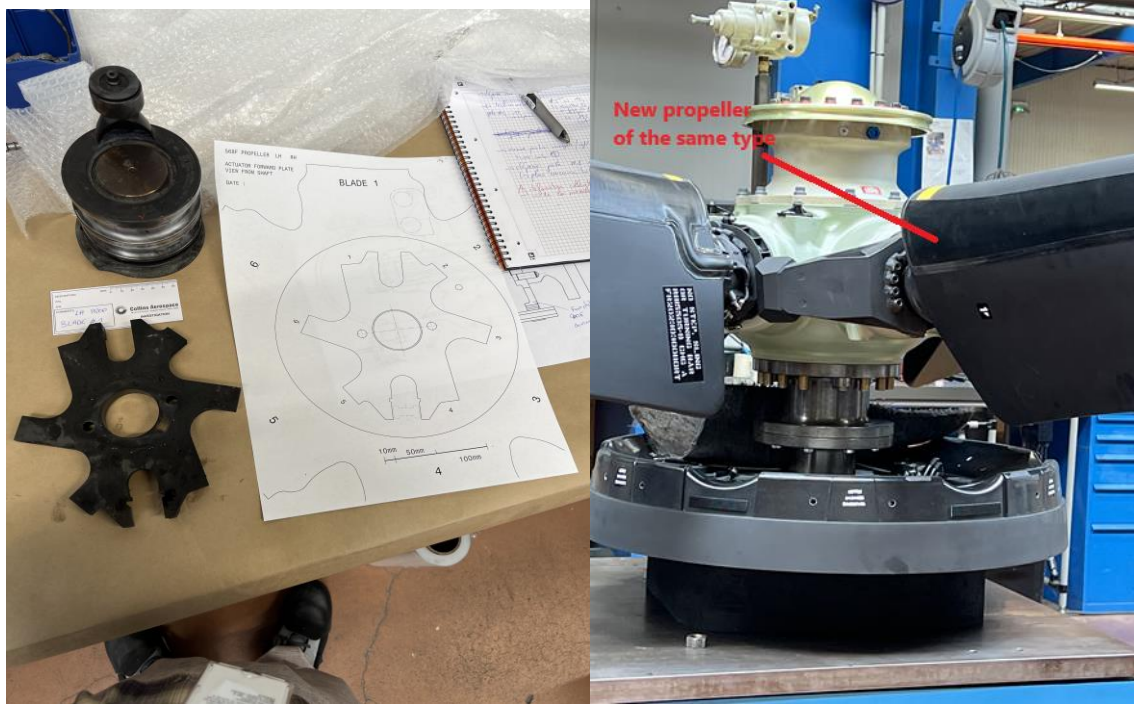
Figure 23 Examination applying different tools and methods

Of the six propeller blades, two of them (4 and 5) were found stuck in a position where the counterweight arm was close to the plane of rotation, therefore in a position close to that of the flag. Damage to the hub to the right of blade 5 due to the counterweight of this blade was also noted. The repositioning of the counterweight in relation to this damage was also noted. The repositioning of the counterweight in relation to this damage corresponded to a blade close to the flag position. The other blades were partially free to rotate around their axis. The pitch change device piston (located in the centre of the hub) was slightly offset from the position corresponding to that of the flag.

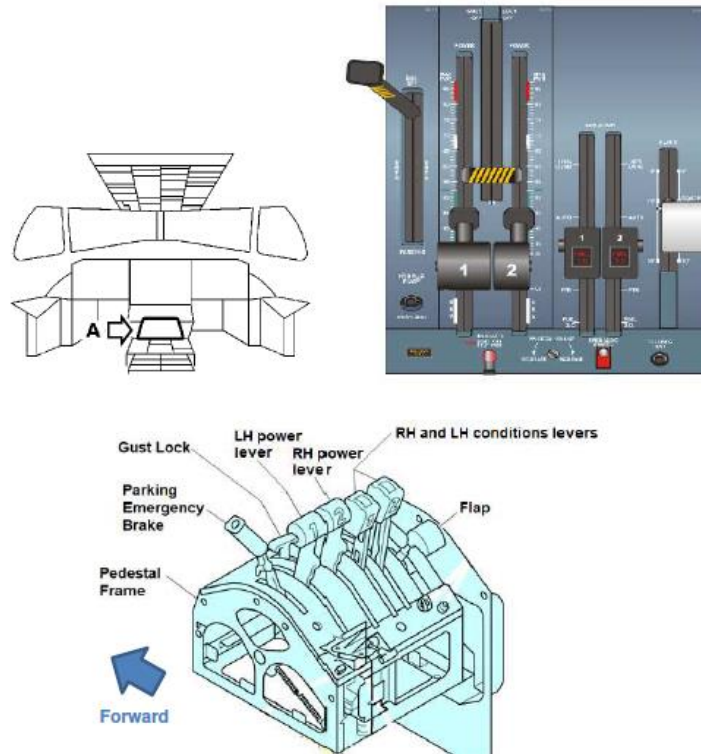
Fig: 26 Pedestal Lever (Source ATR)

- The flap lever was locked in the 30° position, with damage to the lever consistent with the application of a high force from the rear during the accident. As a result, the lever was clearly in the 30° position at impact.
- Traces and impact on the Condition Lever 1 rail are consistent with a FEATHER position at impact (no other impact on other position on the rail of Condition lever 1);
- No trace on the Condition Lever 2;
- Traces and damage on Power levers 1 and 2 are consistent with a position forward (zone corresponding to high power).
- the Gust Lock lever was moved rearward upon impact during the accident sequence and deformed. The lever was therefore forward before impact (normal position in flight). (from BEA COMMENT)

The witness marks from the pedestal indicates that the left condition lever was in the feathered position. Although the right hand condition lever did not have witness marks it is probable that the lever was also in the feathered position based on the FDR data and MFC examination corroboration.
